Restoring the River Wharfe SSSI A River Restoration Plan

Final

December 2013

Natural England

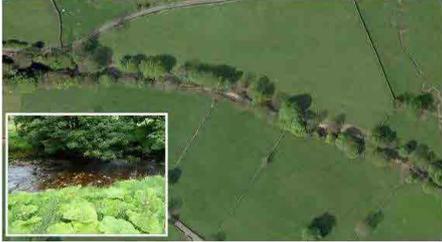
River Type	Vision
<p data-bbox="397 367 568 394">Cobble Step Pool</p>

<p data-bbox="764 367 1366 584">Channel able to meander & move laterally in its corridor. Channel connected to the floodplain. Minimal incision. Increased stability of banks. Riffle, run, cobble step pool structure. Bed composed of gravels and cobbles. Sensitive flood management & riparian land use. Natural patterns of sediment loading, e.g. from tributaries.</p>
<p data-bbox="429 660 536 687">Wandering</p>

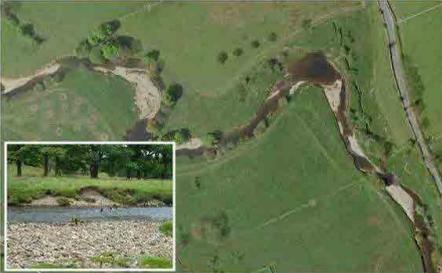
<p data-bbox="764 660 1366 878">Room for the river- river able to move freely, or freely within a defined “erodible corridor” where constraints exist. Channel connected to the floodplain. Bed of medium/coarse gravel & cobbles. Impacts of former gravel extraction have been mitigated. Natural processes e.g. temporary bars related to flood regime.</p>
<p data-bbox="381 985 584 1012">Active Single Thread</p>

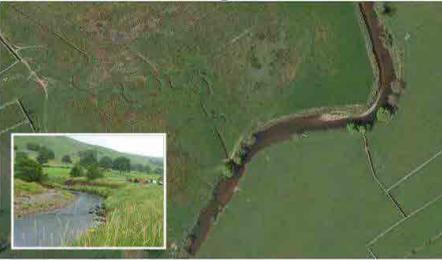
<p data-bbox="764 985 1366 1225">Channel able to meander & move laterally in its corridor. Channel connected to the floodplain. Minimal incision. Increased stability of sand/gravel banks. Riffle, run, pool structure. Bed composed of fine gravel / sand. Sensitive flood management & riparian land use. Natural patterns of sediment loading, e.g. from tributaries.</p>

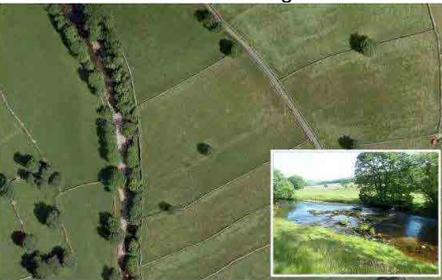
<p data-bbox="320 1296 644 1323">Bedrock Influenced Single Thread</p>

<p data-bbox="764 1296 1366 1491">Channel able to meander & move laterally in its corridor. Channel connected to the floodplain where it is not confined by bedrock. Minimal incision. Increased stability of banks. Riffle, run, cobble step pool structure. Bed composed of gravels and cobbles. Sensitive flood management & riparian land use.</p>

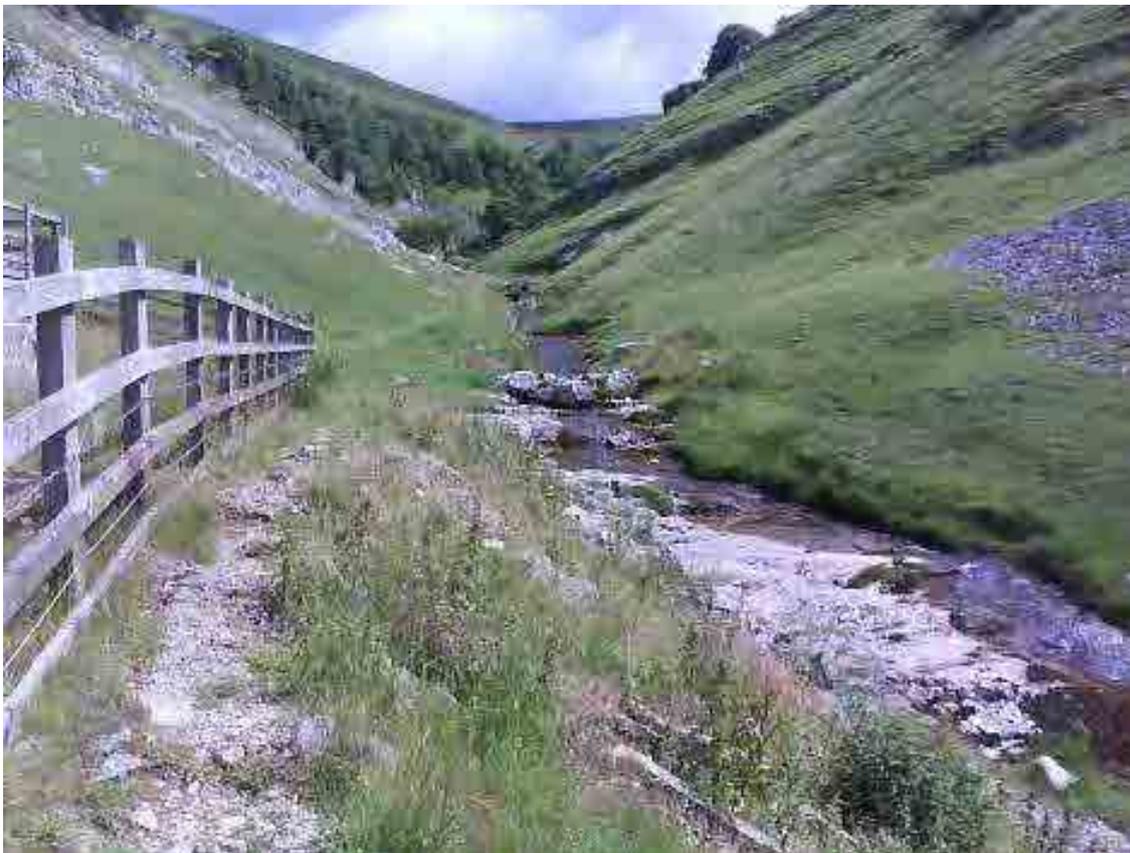
Figure 2-4 Buckden Gill looking up the confined valley. Steep bedrock channel and valley side screes.

The tributary channels of the Upper Wharfe are characterised by a bedrock-dominated morphology (Figure 2-4). They are steep and confined and are capable of efficiently transporting coarse-grained sediment into the main channel during elevated flows. Fine sediment is also generated in the catchment, particularly from forestry activity and diffuse agricultural practices, and may accumulate temporarily in low energy zones along the watercourses. Where these deposits have become vegetated they may be stored for extended periods until a flow of sufficient magnitude occurs to remove the vegetation and associated sediments.

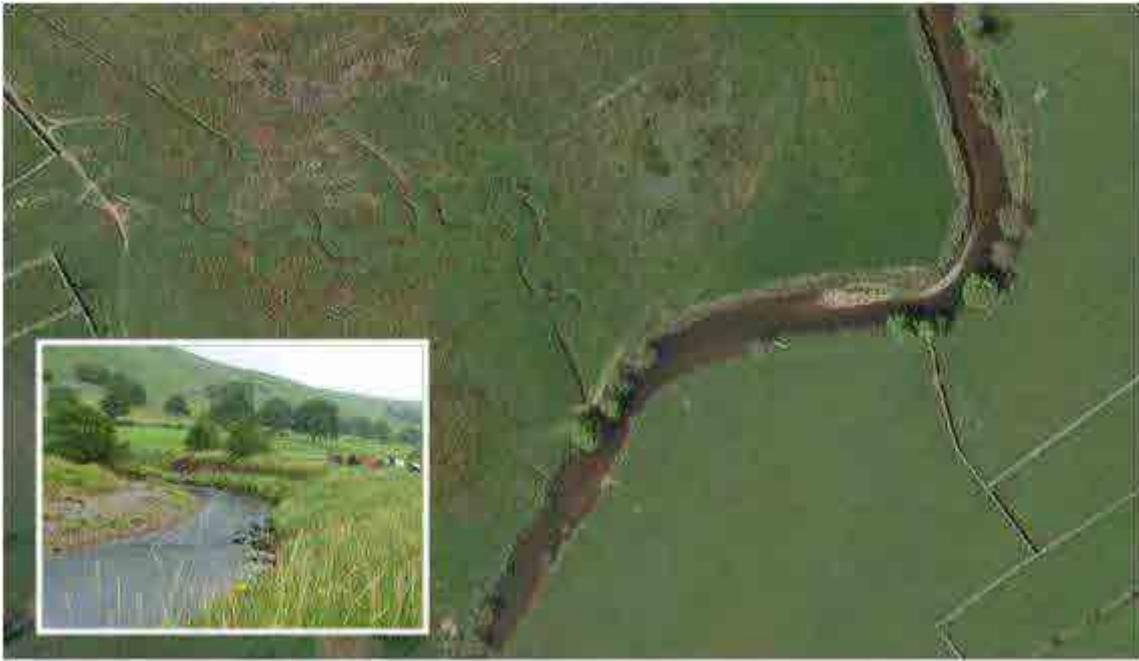
Figure 3-11 Active single thread-pool river type on the River Wharfe SSSI.

This river type is less steep and is characterised by a gravelly bed. The channel is set in a wider valley but is often over-deep due to gravel removal and fluvial incision linked partly to the confinement of flood flows between adjacent flood banks. The river displays stable riffle-pool sequences with occasional plane bed reaches, point bars and lateral bars (Figure 3-11). Again, aquatic mosses (e.g. Alpine Water-moss and Fountain Feather-moss) are the most frequent component of the aquatic flora, but do not cover significant areas as the gravel dominated channel leaves few rocks on which the mosses can grow. In occasional slack areas along the channel margins small patches of wetland species, such as Water-cress *Rorippa nasturtium-aquaticum* develop.

Lateral movement is restricted due to the presence of bank protection and the reduced fluvial energy through these reaches, which in places has resulted in the development of mature, linear Ash and Sycamore woodland on the banks. Channel scouring is also localised and often linked to previous engineering works.

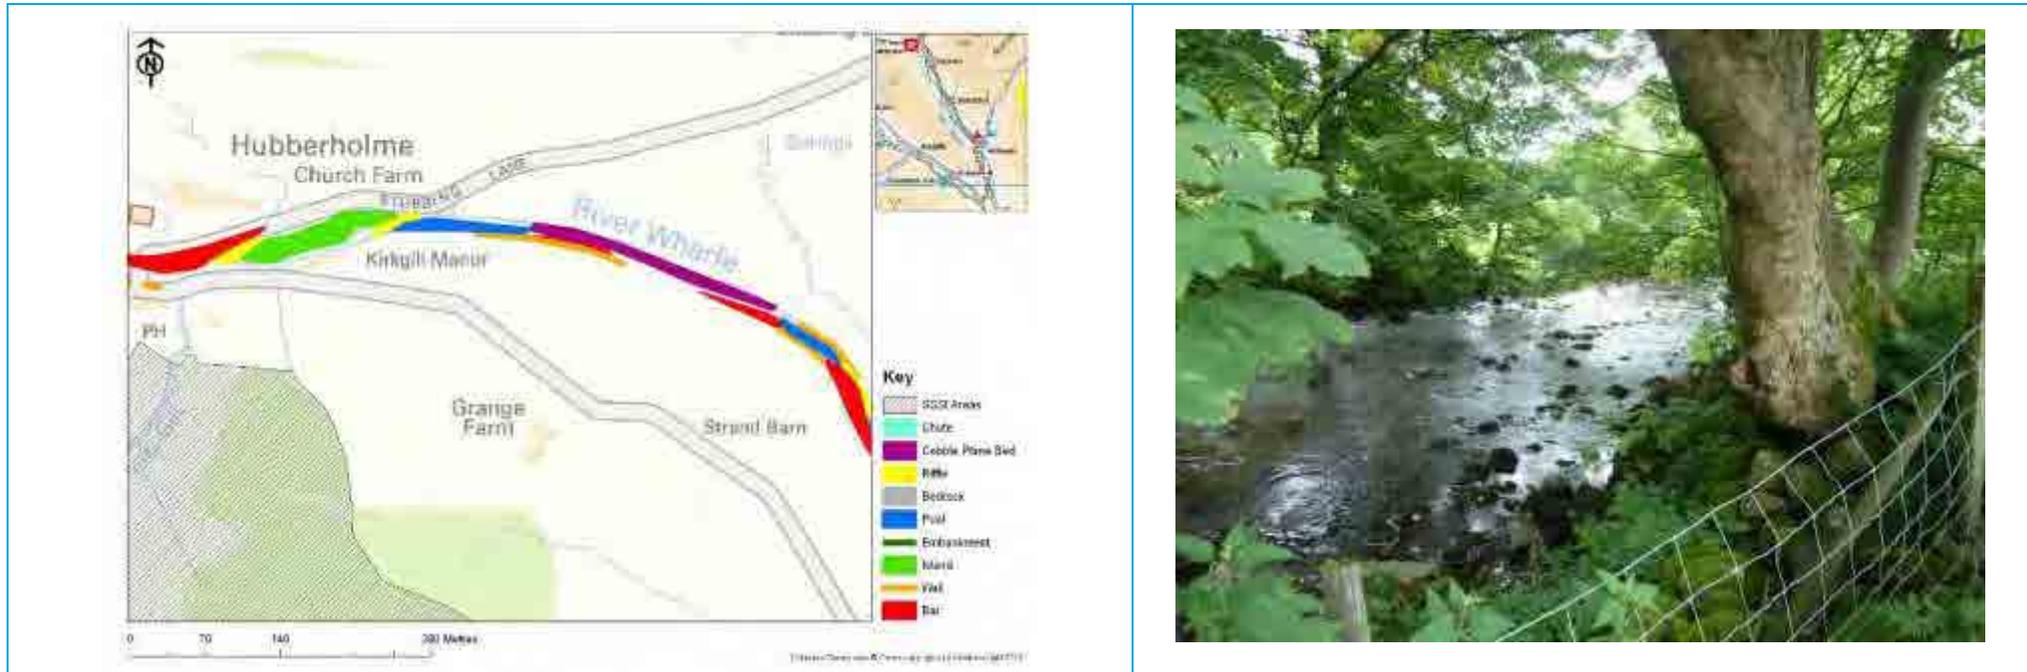
3.8.1 Reach A1 - J: Cobble step-pool (outside the SSSI)

Channel Condition		Floodplain Condition	
River Type (s)	Cobble bed with some level step pool sequences	Valley Type	Narrow floodplain
Responsiveness	High energy, transporting reach with limited gravel deposition, aquatic vegetation development and storage within the channel	Drainage	Several small tributaries impacted by upper catchment gripping
Sediment delivery, type and mobility	Deposition within this section is limited. Where there are small deposits, these tend to be of a large cobble, even small boulder size.	Riparian Vegetation	Tree lined channel banks - Ash, Sycamore and willows
Morphology	Pool, riffle, islands, plane bed and bar development	Palaeo features	None
Incision	Yes – floodplain levels within this reach are generally 2m higher than the normal water level in the Wharfe	Poaching and Grazing Pressures	Limited poaching or grazing pressures due to riparian vegetation
Engineering	Walls lining the edge of the channel

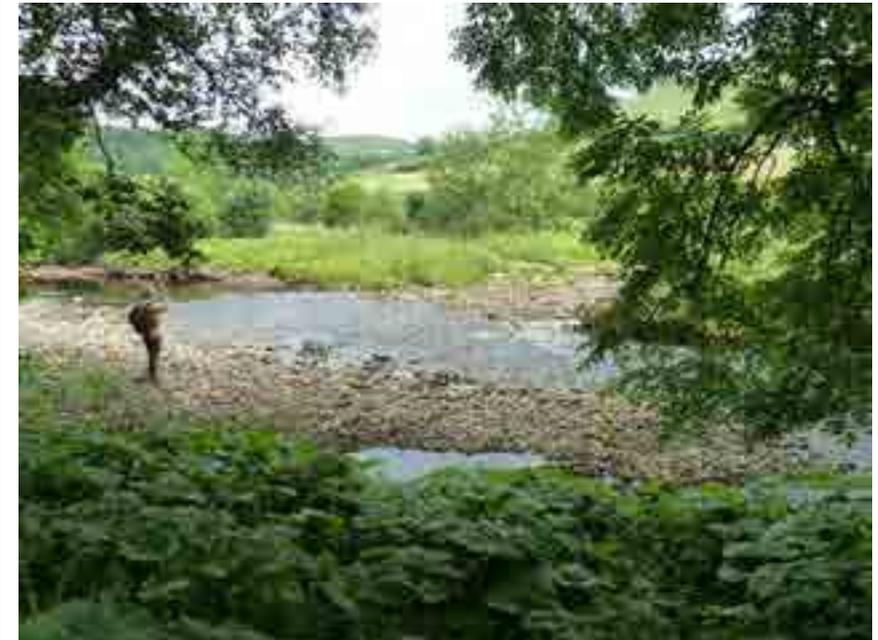
3.8.2 Reach B1 - K: Incipient Wandering (outside the SSSI)

Channel Condition		Floodplain Condition	
River Type (s)	Wandering reach dominated by pools, riffles and deposition	Valley Type	Narrow floodplain
Responsiveness	High energy, transporting reach with limited gravel deposition, aquatic vegetation development and storage within the channel	Drainage	Several small tributaries impacted by upper catchment gripping
Sediment delivery, type and mobility	This reach is characterised by pockets of localised erosion and deposition	Riparian Vegetation	Tree lined channel banks - Ash, Sycamore and willows
Morphology	Pool, riffle, islands, plane bed and bar development	Palaeo features	Upstream of Buckden woods. Reconnection possible
Incision	Limited– floodplain levels within this reach are generally 0.5 m higher than the normal water level in the Wharfe	Poaching and Grazing Pressures	Limited poaching or grazing pressures due to riparian vegetation
Engineering	Walls lining the edge of the channel. Former Buckden gravel trap

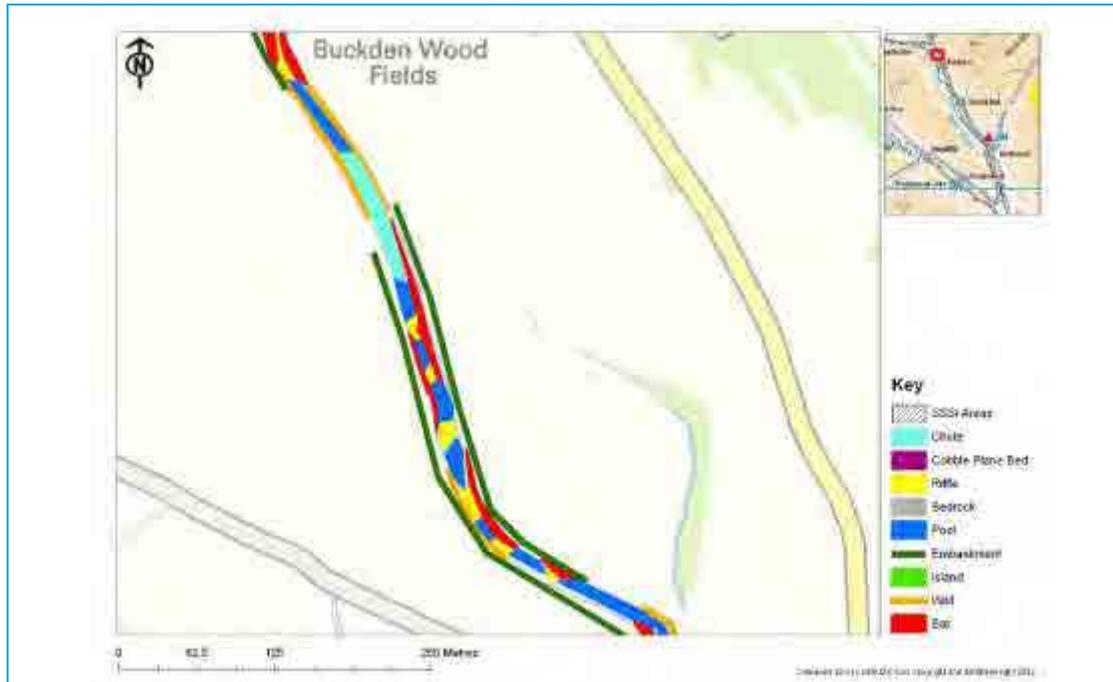
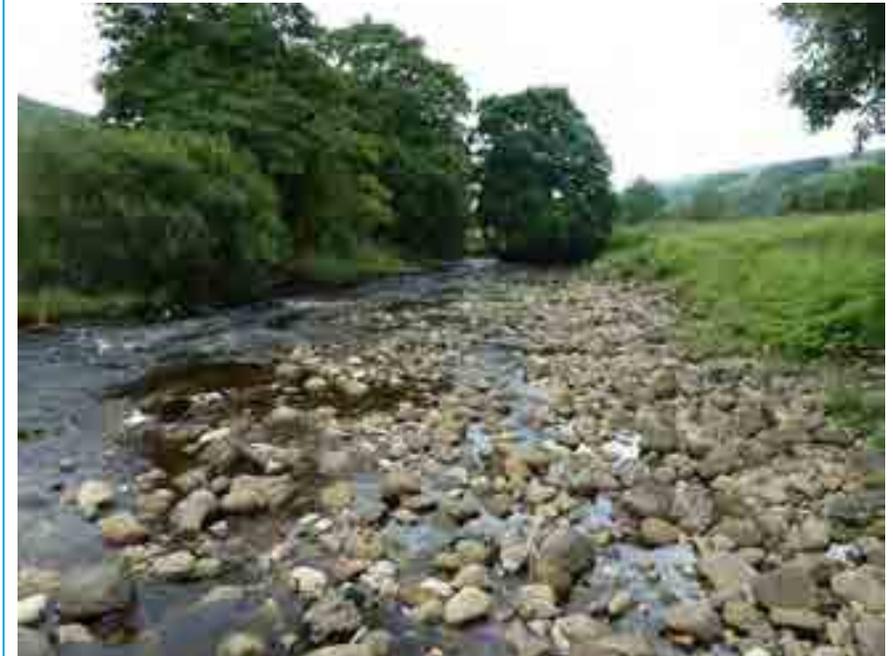
3.8.3 Reach B2 – L: Active Single Thread (outside the SSSI)

Channel Condition		Floodplain Condition	
River Type (s)	Active single thread	Valley Type	Narrow floodplain
Responsiveness	This reach is more transportational than reach B1 – K upstream, with fewer in-channel deposits of gravels and cobbles	Drainage	Several small tributaries impacted by upper catchment gripping
Sediment delivery, type and mobility	Where deposits do exist these tend to be as thin lateral bars at the bank toe, often composed of larger cobbles, several with a covering of aquatic mosses. Longer riffles are evident through this section with some plane bed sections	Riparian Vegetation	Tree lined channel banks - Ash, Sycamore, Crack Willow and Alder trees
Morphology	Pool, riffle, chutes and bar development	Palaeo features	Left bank upstream of Buckden. Reconnection possible.
Incision	Yes – floodplain levels within this reach are generally 1m higher than the normal water level in the Wharfe	Poaching and Grazing Pressures	Limited poaching or grazing pressures due to riparian vegetation

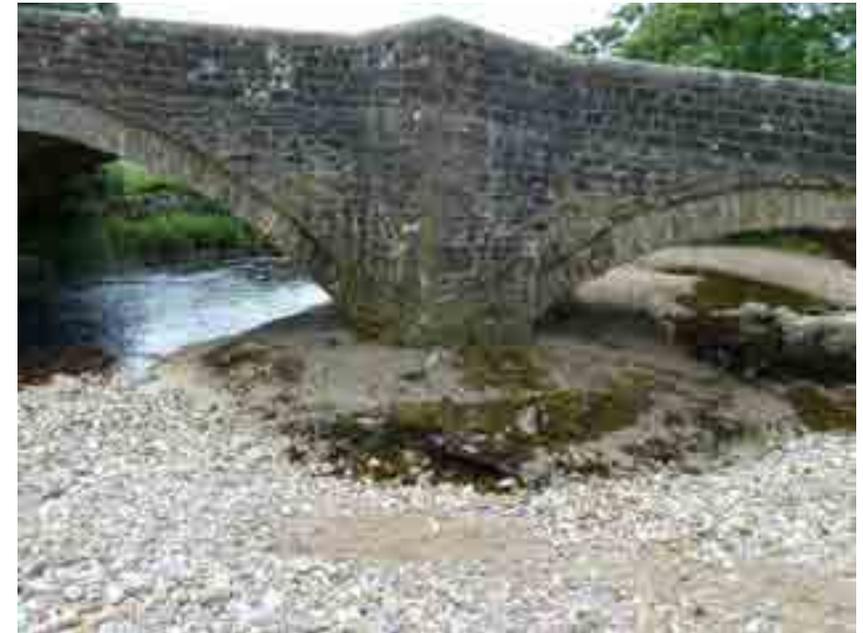
3.8.4 Reach B1 – M: Incipient Wandering

Channel Condition		Floodplain Condition	
River Type (s)	Wandering reach	Valley Type	Narrow floodplain
Responsiveness	This reach contains more gravels than the previous upstream reach. Gravel is deposited at the tight meander bend at Buckden Bridge.	Drainage	Several small tributaries impacted by upper catchment gripping
Sediment delivery, type and mobility	This reach is supplied by the upstream B2 – L transportational reach and the hydraulic impacts of the meander bend have led to the development of the point bar at Buckden Bridge, composed of mainly a mixed gravel fraction with some smaller cobbles.	Riparian Vegetation	Tree lined channel banks - Ash, Sycamore, Crack Willow and Alder trees. The fields on the right bank floodplain generally consist of improved, poor semi-improved and neutral semi-improved grassland fields
Morphology	Pool, riffle and bar development	Palaeo features	None
Incision	Yes – floodplain levels within this reach are generally 1m higher than the normal water level in the Wharfe	Poaching and Grazing Pressures	Limited poaching or grazing pressures due to riparian vegetation

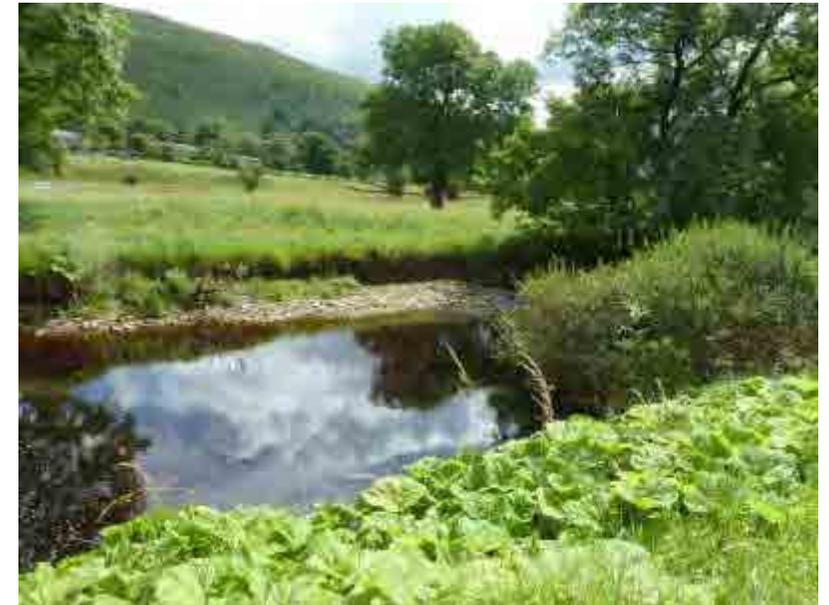
3.8.5 Reach B2 – N: Active Single Thread

Channel Condition		Floodplain Condition	
River Type (s)	Active single thread	Valley Type	Narrow floodplain
Responsiveness	This reach is more transportational with fewer in-channel deposits of gravels and cobbles	Drainage	Several small tributaries impacted by upper catchment gripping
Sediment delivery, type and mobility	This reach is supplied by the upstream B2 – L transportational reach and the hydraulic impacts of the meander bend have led to the development of the point bar at Buckden Bridge, composed of mainly a mixed gravel fraction with some smaller cobbles.	Riparian Vegetation	Tree lined channel banks - Ash, Sycamore, Crack Willow and Alder trees.
Morphology	Pool, riffle and bar development	Palaeo features	None
Incision	Yes – floodplain levels within this reach are generally 1.5m higher than the normal water level in the Wharfe	Poaching and Grazing Pressures	Limited poaching or grazing pressures due to riparian vegetation

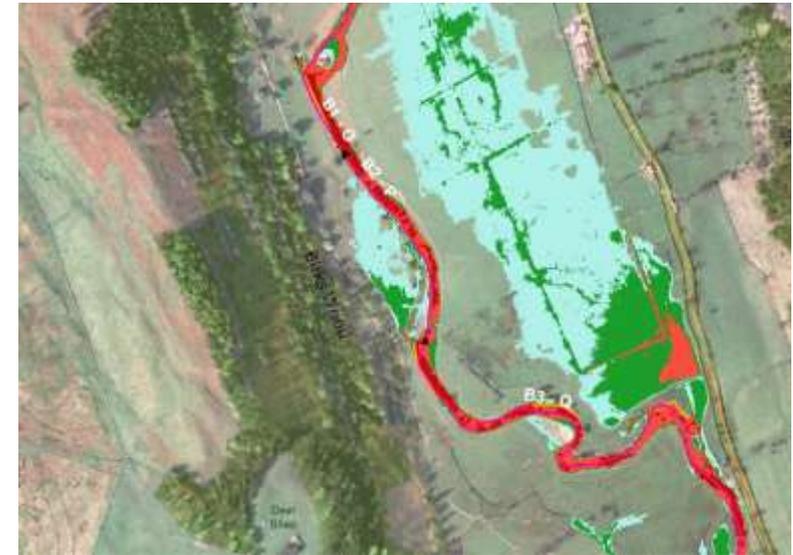
3.8.7 Reach B2 – P Active Single thread

Channel Condition		Floodplain Condition	
River Type (s)	Active single thread	Valley Type	Narrow floodplain
Responsiveness	This reach is more transportational with fewer in-channel deposits of gravels and cobbles	Drainage	Several small tributaries impacted by upper catchment gripping
Sediment delivery, type and mobility	There is one lateral bar on the right bank that is stabilised and vegetated and does not appear to be dynamic under current conditions. Riffle-pool sequencing is moderately well developed through this reach	Riparian Vegetation	Limited tree cover along the banks. The floodplain is dominated by improved grass land coverage.
Morphology	Pool, riffle, chute and bar development	Palaeo features	Right bank. Re-connection from this reach would be limited.
Incision	Yes – floodplain levels within this reach are generally 0.5m higher than the normal water level in the Wharfe	Poaching and Grazing Pressures	Some poaching and grazing pressures were noted due to the lack riparian vegetation

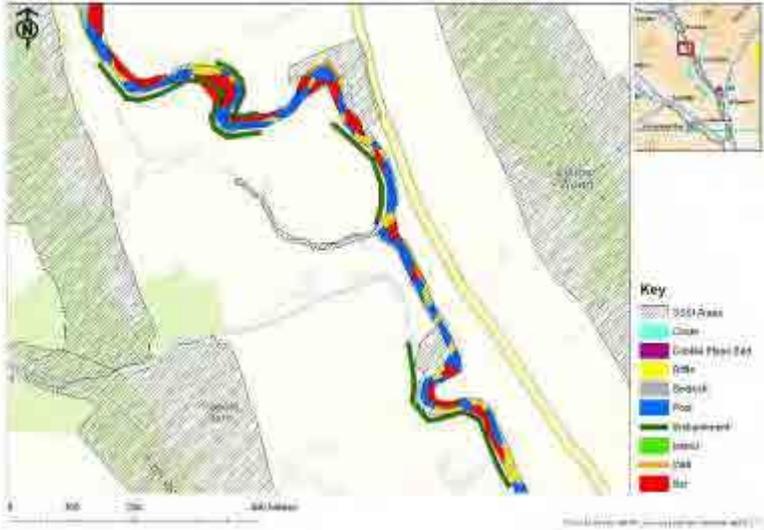
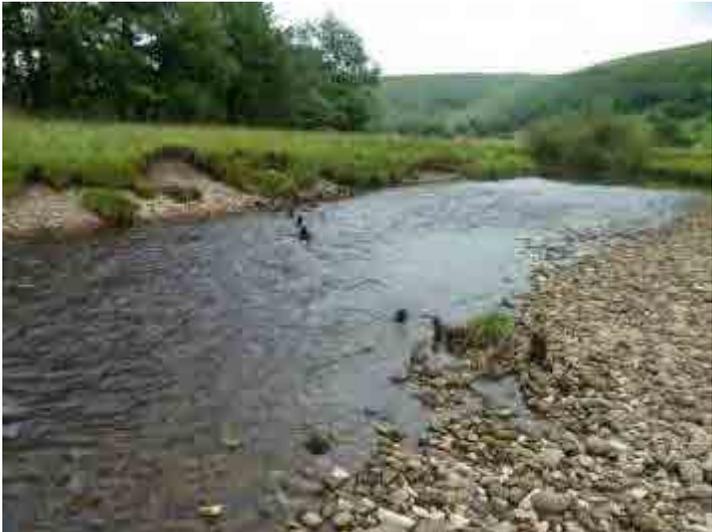
3.8.8 Reach B1 – Q Wandering

Channel Condition		Floodplain Condition	
River Type (s)	Wandering	Valley Type	Narrow floodplain
Responsiveness	This reach is a wandering depositional reach with frequent point bars and lateral bars	Drainage	Several small tributaries impacted by upper catchment gripping
Sediment delivery, type and mobility	In many instances the channel is well connected to the floodplain and is actively wandering and eroding. Bars consist of gravels and cobbles	Riparian Vegetation	Currently this floodplain has a diverse range of habitats, including a cut-off meander, Lesser Pond-sedge beds, Grey Willow-dominated areas of wet woodland, areas of marshy grassland dominated by Meadowsweet and a significant extent of Soft Rush-dominated rushy pasture, all interspersed with areas of poor semi-improved grazed pasture
Morphology	Pool, riffle, chute and bar development	Palaeo features	Several. Historically, the channel has moved across the floodplain through this section

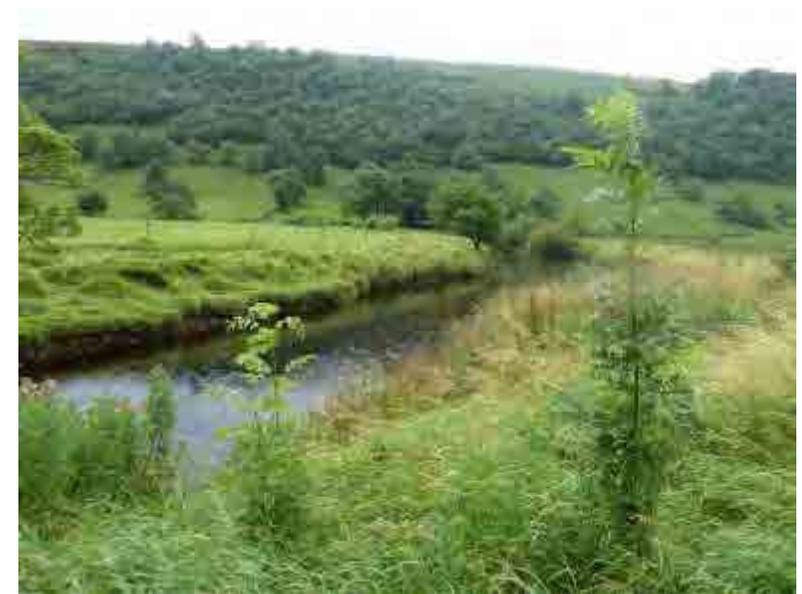
3.8.9 Reach B2 – R Active Single Thread

Channel Condition		Floodplain Condition	
River Type (s)	Active single thread	Valley Type	Narrow floodplain
Responsiveness	This reach becomes more transportational with fewer in-channel deposits of gravels and cobbles	Drainage	Several small tributaries impacted by upper catchment gripping
Sediment delivery, type and mobility	In many instances the channel is well connected to the floodplain and is actively wandering and eroding. Bars consist of gravels and cobbles	Riparian Vegetation	Wet woodland and rushy pasture.
Morphology	Pool, riffle, chute and bar development	Palaeo features	Right bank. Better connection could be achieved.
Incision	Yes – This reach appears to be incised meaning floodplain connectivity is limited. The floodplain is >2m above the normal water level in the Wharfe	Poaching and Grazing Pressures	Some poaching and grazing pressures were noted due to the lack riparian vegetation
Engineering	Embankments line the edges of the channel and bank protection is common in several areas

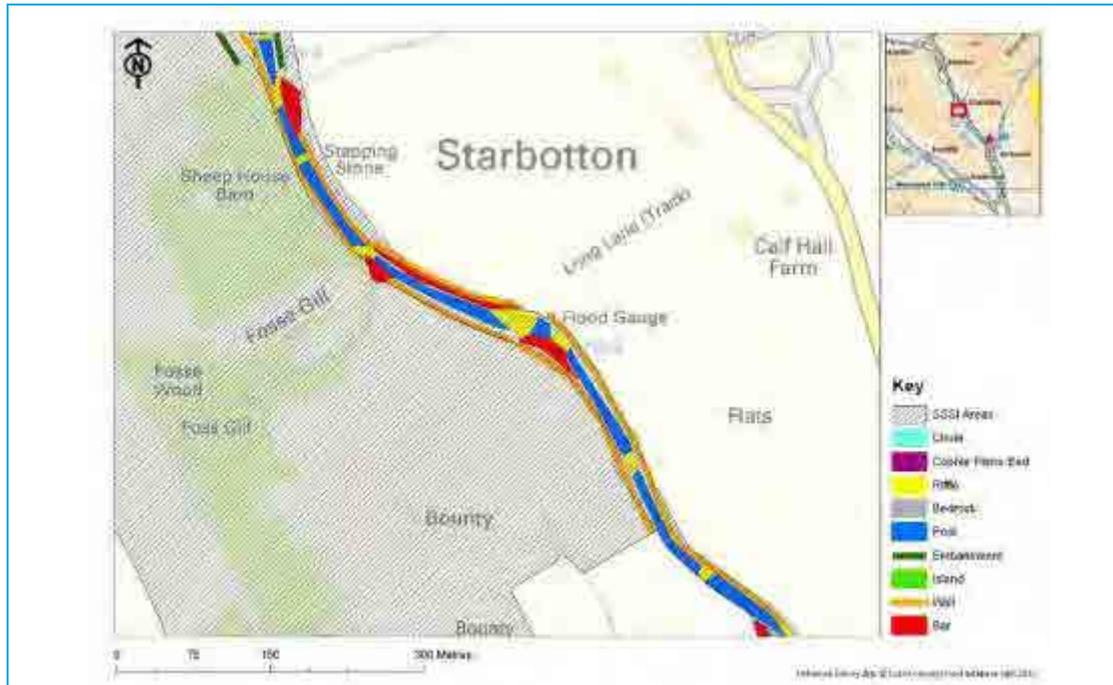
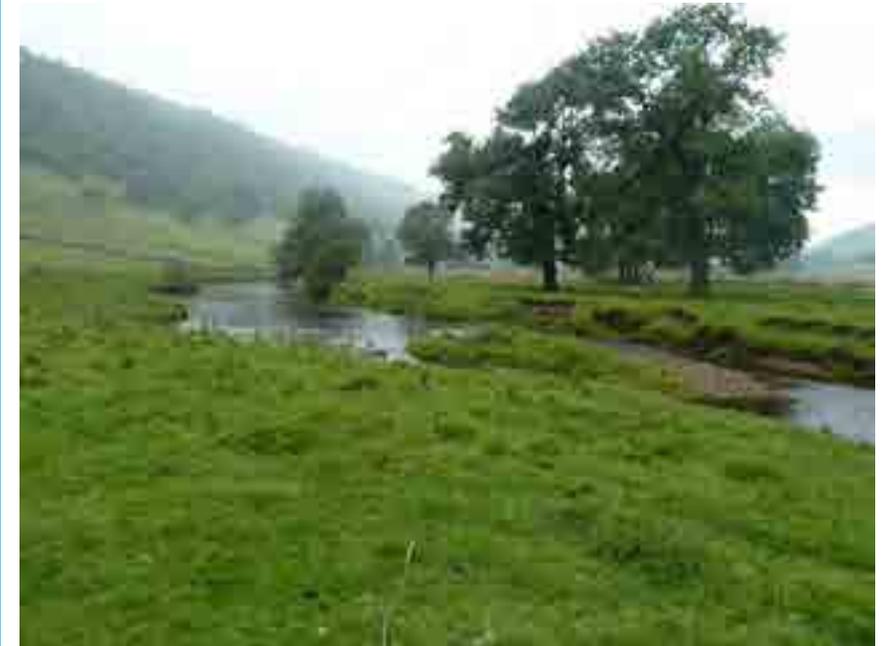
3.8.10 Reach B2 – S Active single thread - Plane Bed

Channel Condition		Floodplain Condition	
River Type (s)	Active single thread - Plane bed	Valley Type	Narrow floodplain
Responsiveness	This reach is generally a transportational plane bed cobble and gravel, despite a significant source of coarse sediment from Cam Gill Beck and Fosse Gill	Drainage	Several small tributaries impacted by upper catchment gripping
Sediment delivery, type and mobility	Sediment input from tributaries. The reach is straight and has few in-channel depositional features, barring one part vegetated, small point bar	Riparian Vegetation	Marshy pasture and improved grassland. Left and right banks. Connectivity could be improved
Morphology	Pool, riffle and bar development	Palaeo features	Some poaching and grazing pressures were noted due to the lack riparian vegetation
Incision	Yes – This reach appears to be incised meaning floodplain connectivity is limited. The floodplain is 1-1.5m above the normal water level in the Wharfe	Poaching and Grazing Pressures

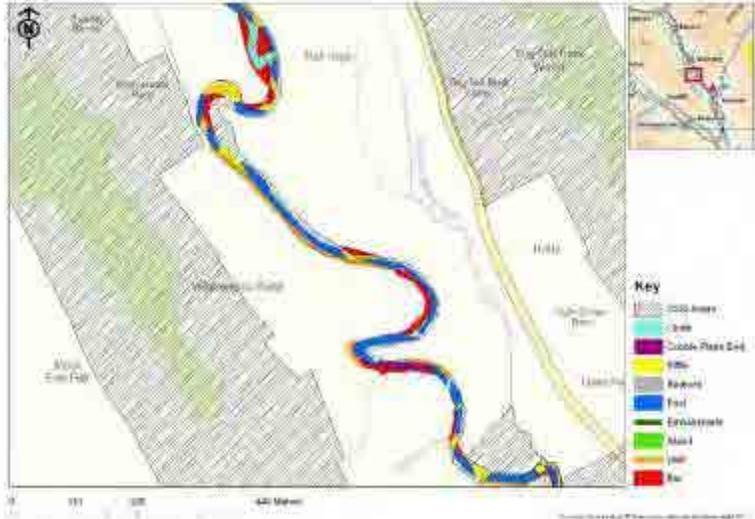
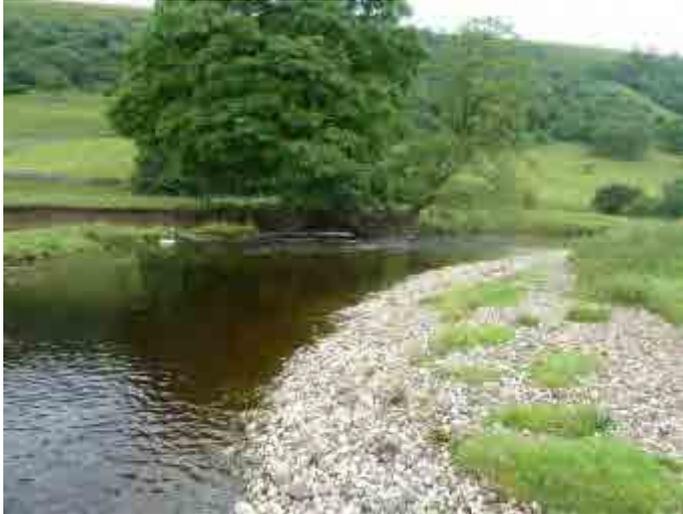
3.8.11 Reach B1 – T Incipient Wandering

Channel Condition		Floodplain Condition	
River Type (s)	Wandering	Valley Type	Narrow floodplain
Responsiveness	This reach is depositional with significant in-channel gravel / cobble features such as lateral bars, mid-channel bars and point bars	Drainage	Several small tributaries impacted by upper catchment gripping
Sediment delivery, type and mobility	The significant depositional features have created associated outer bank erosion with some local channel widening, again providing an important local sediment source to the system locally	Riparian Vegetation	Marshy pasture and improved grassland.
Morphology	Pool, riffle and bar development	Palaeo features	Floodplain palaeo channels have developed into chute channels through the large gravel bar deposit adjacent to Hall Ings, and these areas have considerable habitat and botanical diversity
Incision	Limited –The floodplain is <1m above the normal water level in the Wharfe in most instances	Poaching and Grazing Pressures	Some poaching and grazing pressures were noted due to the lack riparian vegetation

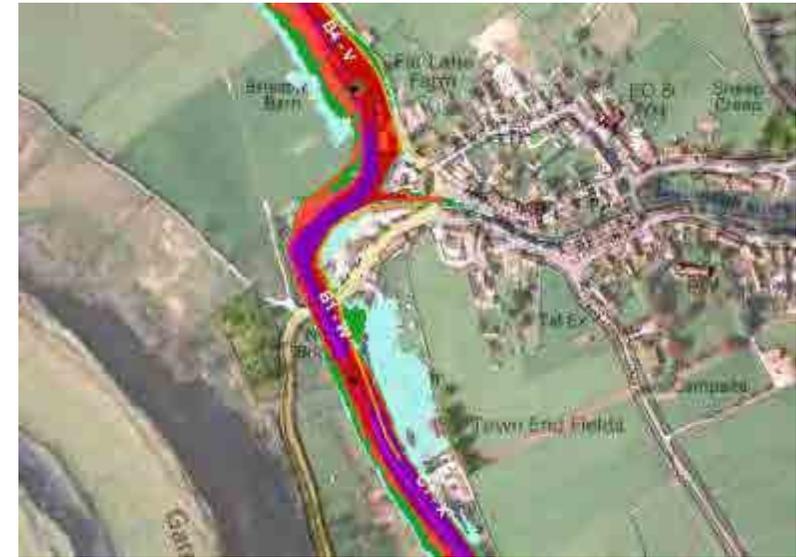
3.8.14 Reach B1 – W Incipient Wandering

Channel Condition		Floodplain Condition	
River Type (s)	Wandering	Valley Type	Narrow floodplain
Responsiveness	The upstream transportational reach B2 – U and B4 – W supply this depositional reach.	Drainage	Several small tributaries impacted by upper catchment gripping
Sediment delivery, type and mobility	There are significant gravel deposits at the confluence with Kettlewell Beck, as well as upstream where an island has developed creating bifurcated flow. This island is obviously relatively stable and densely vegetated with willow dominated scrub	Riparian Vegetation	Pasture and urban
Morphology	The reach is dominated by mid-channel bars (island), lateral bars and point bars, which are generally un- or sparsely vegetated. These are composed of a mixed gravel fraction with some cobbles	Palaeo features	None
Incision	Floodplain connectivity is generally restricted through this reach as a result of the confined valley and high floodplain levels close to both banks	Poaching and Grazing Pressures	Limited poaching and grazing pressures were noted

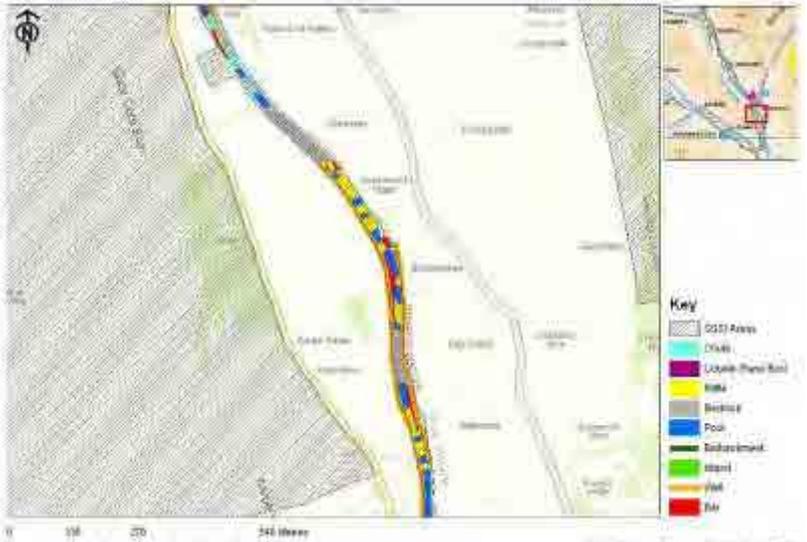
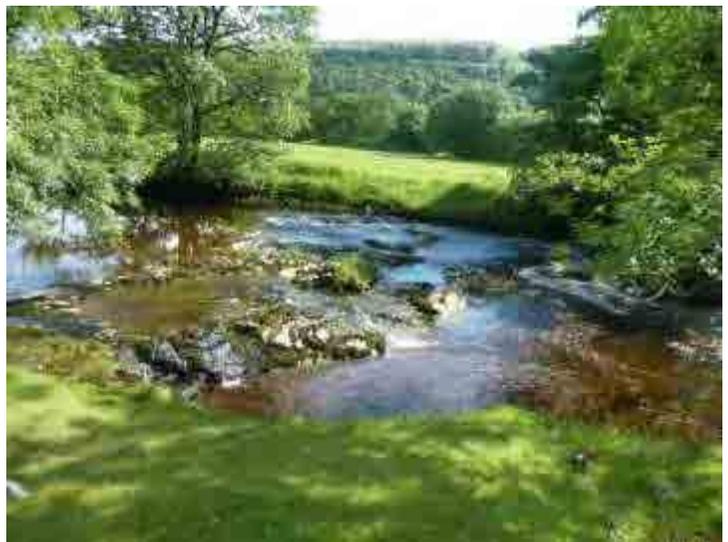
3.8.15 Reach C1 – X Bedrock Influenced

Channel Condition		Floodplain Condition	
River Type (s)	Bedrock	Valley Type	Narrow floodplain
Responsiveness	The reach is transportational with only small, sporadic deposits of larger cobbles, which exist mainly where there is local improved connectivity to the floodplain	Drainage	Several small tributaries impacted by upper catchment gripping
Sediment delivery, type and mobility	Higher energy in-channel hydromorphic features are common including chutes and riffles	Riparian Vegetation	Semi-improved neutral grassland
Morphology	The reach is generally bedrock dominated, with large cobbles forming the majority of the bed, and some small boulders	Palaeo features	None
Incision	Floodplain connectivity is generally restricted through this reach as a result of the confined valley and high floodplain levels close to both banks	Poaching and Grazing Pressures	Limited poaching and grazing pressures were noted

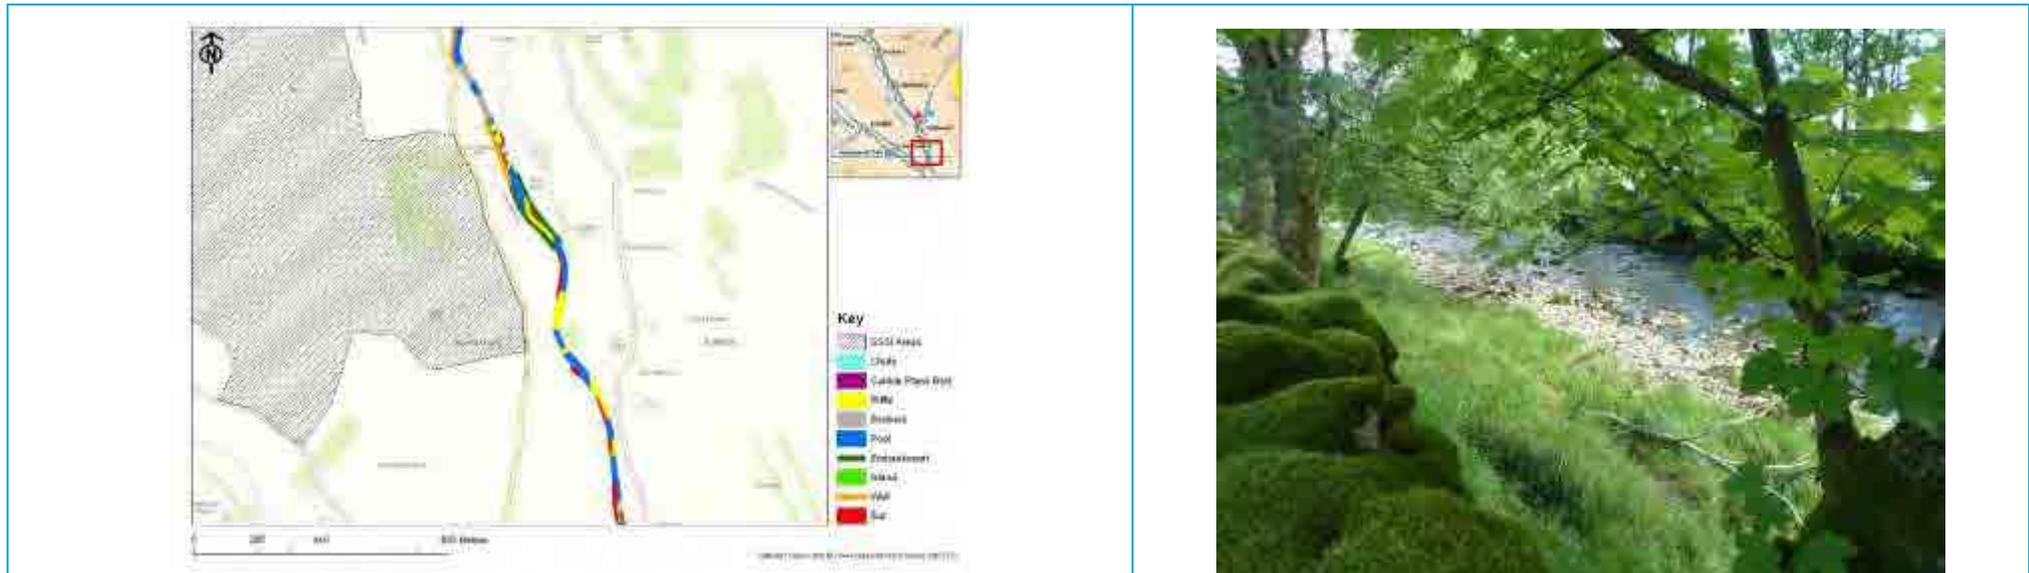
3.8.16 Reach A2 – Y Cobble Step-Pool (outside the SSSI)

Channel Condition		Floodplain Condition	
River Type (s)	Cobble step pool	Valley Type	Narrow floodplain
Responsiveness	this reach is generally transportational with very few in-channel depositional features and a generally cobble lined bed	Drainage	Several small tributaries impacted by upper catchment gripping
Sediment delivery, type and mobility	Riffle – pool sequencing are the dominant units through this reach and where small bars do exist, these have often become stabilised with mature vegetation, generally dominated by Reed Canary-grass	Riparian Vegetation	Semi-improved neutral grassland
Morphology	The reach is generally bedrock dominated, with large cobbles forming the majority of the bed, and some small boulders	Palaeo features	None
Incision	Floodplain connectivity is generally restricted through this reach as a result of the confined valley and high floodplain levels close to both banks	Poaching and Grazing Pressures	Limited poaching and grazing pressures were noted

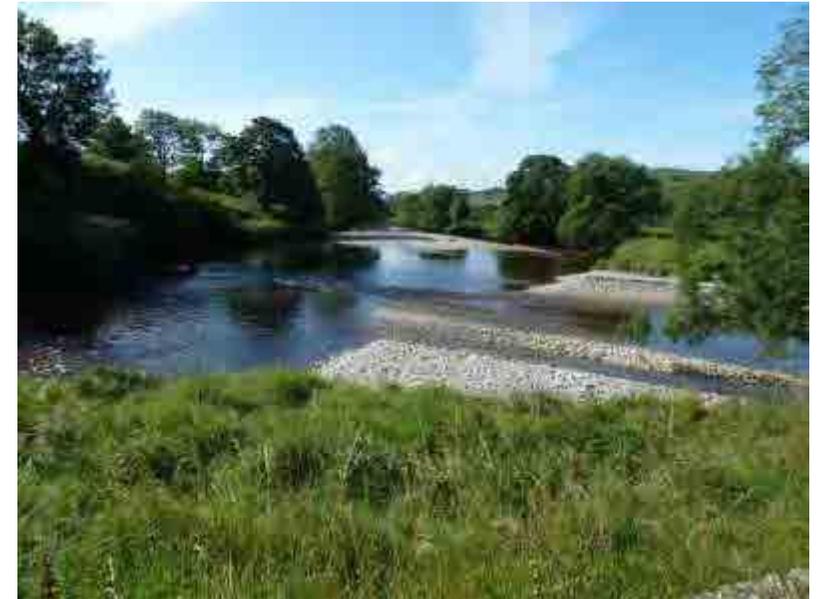
3.8.17 Reach B2 – Z Active Single Thread (outside the SSSI)

Channel Condition		Floodplain Condition	
River Type (s)	Active single thread	Valley Type	Narrow floodplain
Responsiveness	Whilst generally transportational, there are some in-channel depositional features, particularly close to the confluence with the Skifare, composed of un-vegetated cobbles	Drainage	Several small tributaries impacted by upper catchment gripping
Sediment delivery, type and mobility	There is a riffle – pool sequence through this short reach, with a gravel deposit on the right bank. A significant amount of sediment enters the Wharfe from the Skifare.	Riparian Vegetation	Adjacent meadows are species-rich and dominated by Meadowsweet and Lesser Pond-sedge
Morphology	A large pool has formed at the confluence with the Skifare, but downstream of the confluence, depositional features are more common as the Skifare is a significant gravel source to downstream reaches of the Wharfe	Palaeo features	None

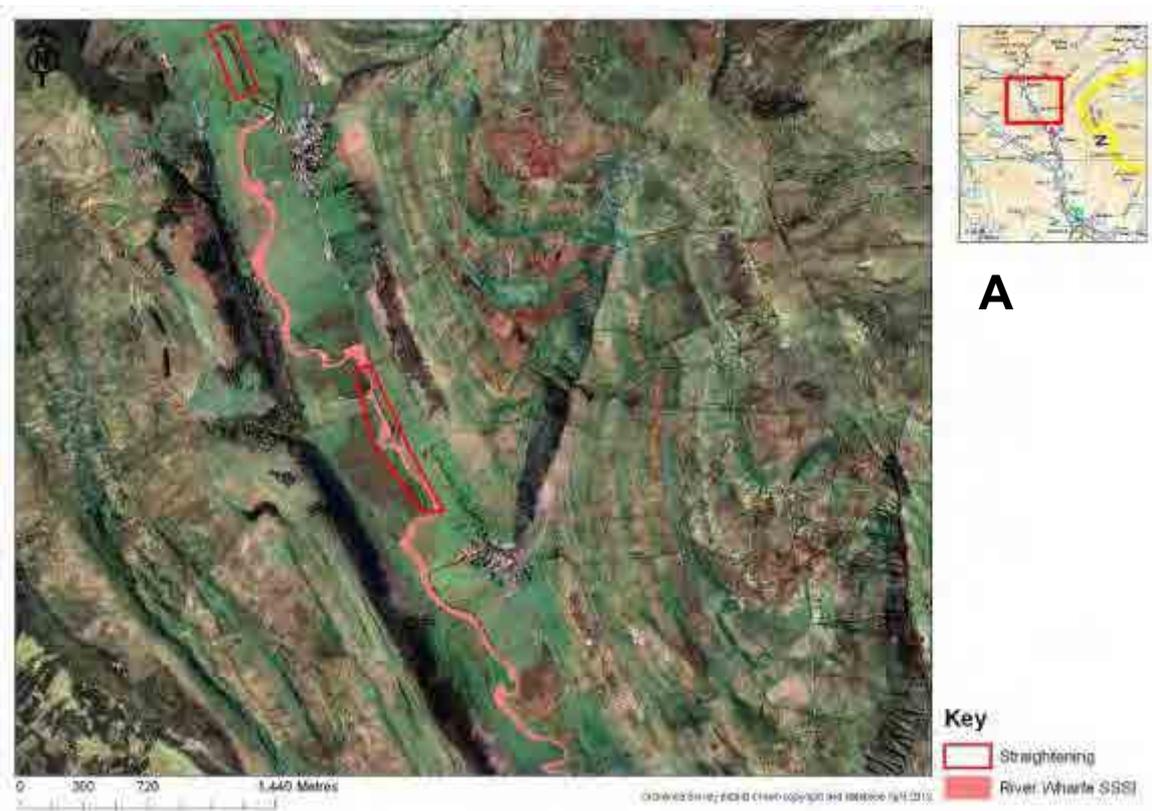
Figure 4-3 Location of significant channel straightening along the River Wharfe SSSI (maps A and B).

Documented evidence of historic channel straightening is rare. Analysis of aerial photographs of the river and floodplain suggest that realignment has occurred at several locations (Figure 4-3) leaving floodplain palaeo-features isolated in the landscape. Other areas may also have been straightened and have responded by cutting down into the bed rather than by eroding laterally due to the presence of revetment.

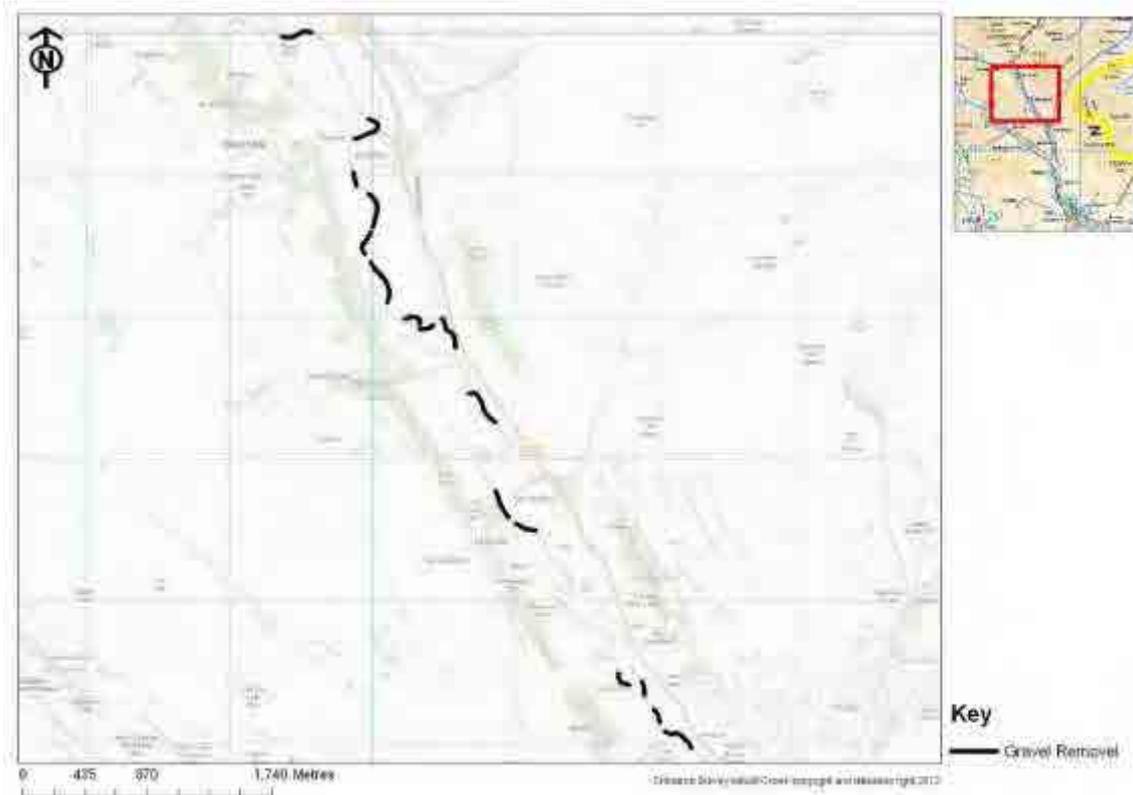
Figure 4-5 Locations of gravel removal as part of the during the Buckden Flood Alleviation Scheme during the 1980's

Many of these features have returned or are returning and much of the current gravel shoaling and bank erosion activity can be attributed to historic gravel removal. Where feasible no further gravel should be removed from the river. This will also ensure fish spawning areas are protected. In all cases it is hydromorphologically detrimental to remove gravel from the active transport system as it disrupts system morphology and transport continuity, impacts on in-channel habitats, alters the frequency and extent of natural overbank flooding and temporarily elevates fine sediment levels during removal impacting on downstream gravel integrity. Should flood risk considerations override hydromorphic disruption then all removed material should be reintroduced to the system as close as possible downstream where flood risk is not an issue avoiding local system overloading and ensuring that it is assimilated into the natural transport regime with the minimum of local disruption

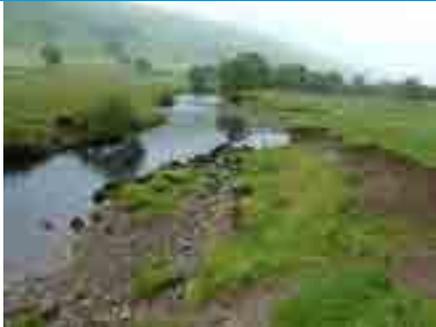
Pressure	Consequence	Example
<p>Bed Erosion and Bank Instability</p> <p>The effects of bed lowering through repeat dredging has encouraged in-channel bed erosion and bank instability</p>	<p>Livestock have utilised the collapsed banks to gain access to the river in a number of locations leading to enhanced erosion of the banks (poaching).</p> <p>Increased input of fine sediment into the channel which leads to increased in channel siltation.</p> <p>A more uniform channel reduces the habitats within the river (i.e. fewer refuges for shelter).</p> <p>Limited bankside vegetation due to erosion and as a result a decline in habitat.</p>

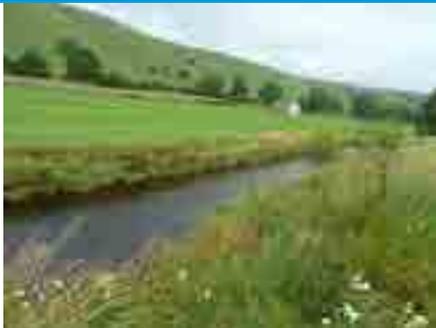
<p>Flood Embankments</p> <p>Flood banks have caused channel incision by confining higher energy in channels flows.</p>	<p>The bed of the river is now disconnected (due to incision) from the floodplain along many reaches.</p> <p>As this erosion continues the risk of embankment failure increases.</p> <p>If embankments are overtopped flow can become trapped behind them.</p>

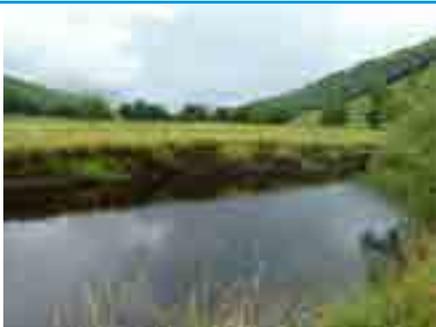
<p>Lack of Trees</p> <p>Several reaches have poor riparian vegetation cover compared to the typical natural landscape of the area and what would provide a good riparian condition</p>	<p>Limits the amount of woody debris entering the channel which limits the cover for fish and creates less habitat diversity</p> <p>Banks will become more vulnerable to erosion.</p> <p>Remnant riparian woodland is non-existent and much of the river bank is characterised by mature single trees (Sycamore, Alder, and Ash).</p>

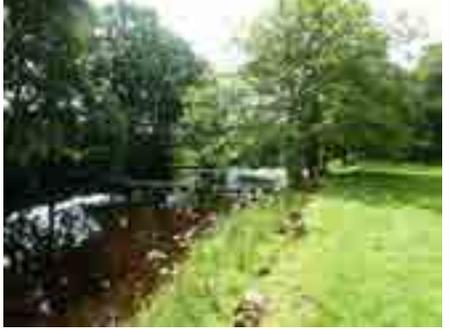
Pressure	Consequence	Example
<p>Floodplain Management</p> <p>Current and historic floodplain farming practices have significantly altered the natural habitats and vegetation on the floodplain, with riparian character seriously altered.</p>	<p>Much of the floodplain is now semi-improved neutral grassland, often of limited species-richness or heavily improved pasture, with only limited areas of wetland vegetation (e.g. rushy pasture, pools, sedge beds, wet grassland). Remnant riparian woodland is non-existent and much of the river bank is characterised by mature single trees (Sycamore, Alder, Ash).</p>

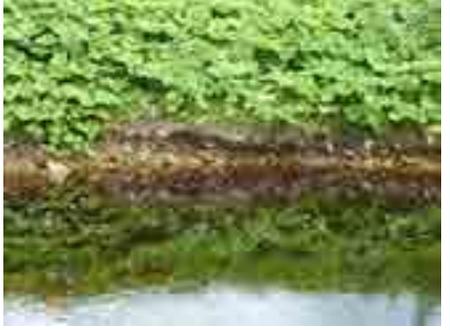
<p>Invasive Species</p> <p>Japanese Knotweed at the confluence of Buckden Beck and several patches of Himalayan Balsam just upstream of Kettlewell have been noted. North American Signal Crayfish are believed to be present throughout the surveyed reach of the Wharfe, and also potentially the larger tributaries.</p>	<p>Die back of invasive species during winter months leaves banks exposed and prone to erosion</p> <p>Quickly spread and can lead to a decline in native species</p>

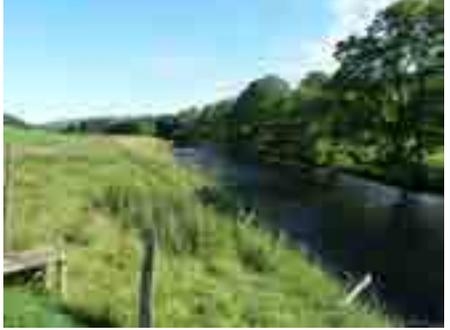
<p>Lack of Floodplain Connectivity</p> <p>Several factors contribute to this including embankments concentrating in channel flows and gravel removal increasing incision</p>	<p>A reduction in the frequency of floodplain connection means that fine sediment is deposited within the channel and not on the floodplain.</p> <p>Too much fine sediment in the channel can effect and reduce spawning habitats.</p>

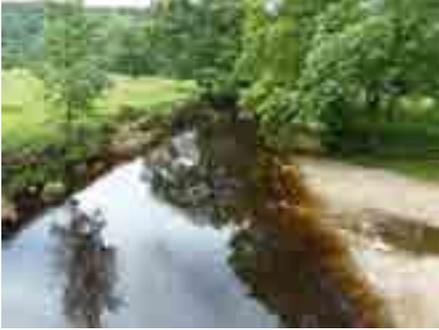
Pressure	Consequence	Example
<p>Channel Training</p> <p>Bank revetment, which is a form of channel training, is extensive along the river in various forms ranging from walling to blockstone.</p>	<p>Reduced channel maintenance means that areas of historic protection are now failing and the channel response in the form of lateral erosion must be planned for.</p>
