Restoring the River Wharfe SSSI A River Restoration Plan

Final

December 2013

Natural England

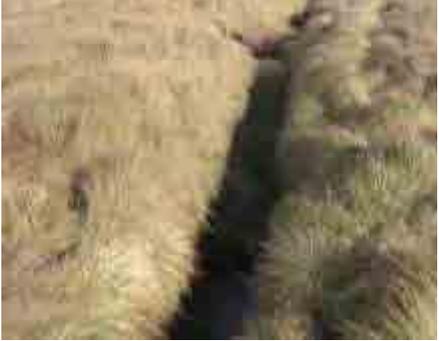
<p>Flow Regime Alteration</p> <p>The rivers flashy flow regime has been intensified by moorland gripping in the upper catchment.</p>	<p>Moorland gripping has led to increased run off and fine sediment input.</p>

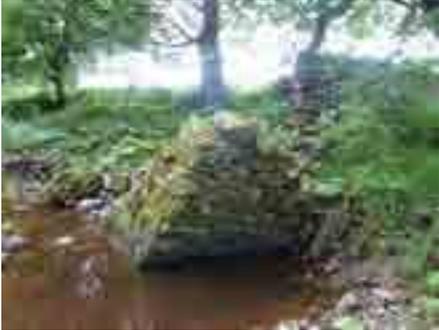
<p>In Channel Structures</p> <p>Weirs and culverts can impound the river increasing water levels upstream and disrupt sediment continuity.</p>	<p>There is a reduction in flow depth variation and velocity as a result of structures being in place.</p> <p>Fish passage is reduced / prevented and the range of habitats is reduced.</p>

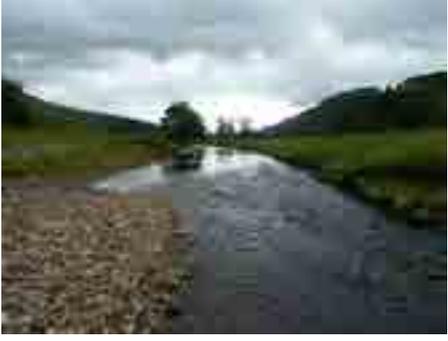
Pressure	Consequence	Example
<p>Channel Realignment</p> <p>In some areas the channel may have been straightened</p>	<p>The river has responded to straightening by cutting down into the bed rather than by eroding laterally due to the presence of revetment.</p>

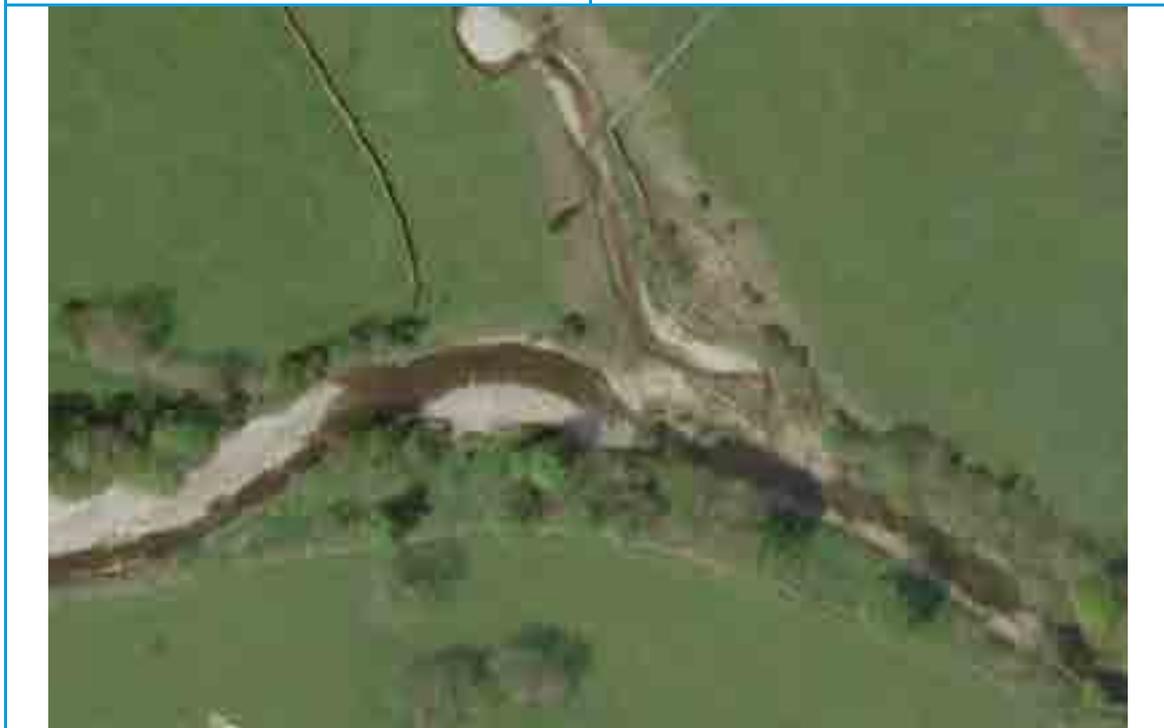
Tributary Junction Development
Description: Setting back of flood embankments, controlling livestock access to encourage a more naturalised tributary junction

Benefits	Constraints
<ul style="list-style-type: none"> • Further development of well connected morphology and ecology, including several bars. • Setting back embankments and increasing floodplain connectivity should promote diversity and extent of riparian habitats and associated invertebrate communities and therefore an increase in abundance of prey species • Wetland habitat creation at tributary junction through increased inundation. • Development of tributary junction likely to provide diverse flow regimes and in channel diversity. 	<ul style="list-style-type: none"> • Minimal release of sediment during works. This will be rapidly assimilated into the transport regime and will have minimal impact on fisheries. • Minor, localised disturbance to species and habitats during works. • Potential for rank, disturbance-tolerant vegetation to develop if inundation is infrequent or compaction occurs during works • Braided channel and consequent reduction in channel depth may reduce accessibility to tributary for larger adult fish • Some land loss in order to control livestock

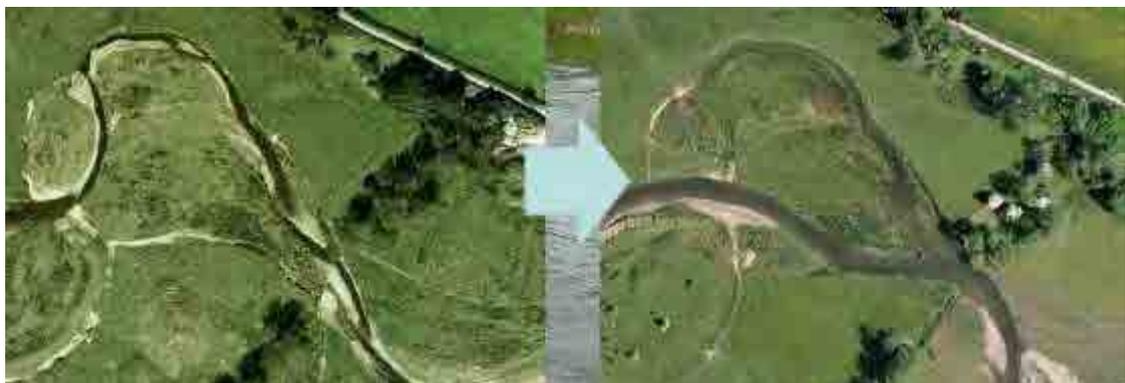
Chute Channel Creation
Description: The creation of high flow meander cut offs will offer flow variability and allow the river to migrate

Benefits	Constraints
<ul style="list-style-type: none"> • Approach works with the current point bar morphology and processes operating as part of the chute channel cut-off process leading to channel isolation and abandonment. • Enhancement of high flow chute channel will divert low and medium flood flow and associated erosive energy away from the outer bend. • High flow 'chute' will provide new periodically wet habitat, and increase habitat diversity across the immediate riparian zone. • Potential for creation of more 'natural' habitats over the more isolated bar surface created behind chute channel. • Retention of valuable deeper pool refuge and feeding station habitat, likely to be exploited by larger adult fish, on meander bend. <p>Development of diversity of morphological features will provide increased habitat and flow diversity exploitable by all life stages.</p>	<ul style="list-style-type: none"> • Likely to cause longer term channel adjustment up and downstream but this mimics natural cut-off process. • Minor, localised disturbance to species and habitats during works. • Natural maturation of point bar features will be disrupted. However, retention of diverse habitat promoted by this proposal will likely outweigh any limitation associated with natural development of backswamp/oxbow feature. • Some land loss along riparian margin. • Potential spread of non-native invasive plant species.

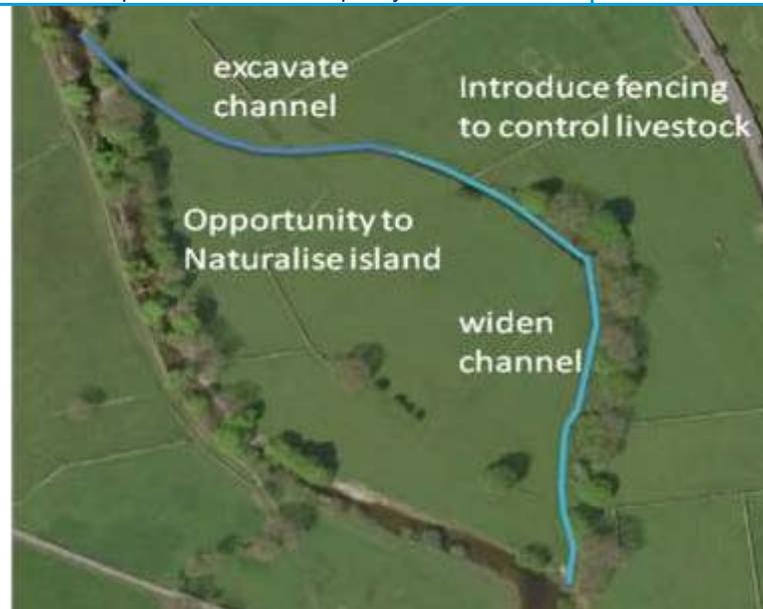
Opportunity	Actions	Positive response	Considerations and constraints
Main channel bifurcation.	Permanent connection of the Main River Wharfe to the left bank palaeo-channel through a short excavated channel Control stock access by managing grazing intensity by temporary or permanent fencing	Creation of high flow secondary channel with associated habitats. In terms of fisheries these will be particularly valuable for juvenile life stages during normal flows. Reduced energy in main channel leading to development of gravel features and eroding banks. Increase in prevalence of gravel features in main channel likely to provide spawning opportunities, as well as providing more abundant prey species habitat. Opportunity to naturalise floodplain 'island' and introduce varied wetland, grassland and woodland habitats with consequent increase in diversity and abundance of invertebrate prey species. Creation of temporal and habitat variety across the floodplain. Improved local flood capacity.	Short term disruption to gravel transfer downstream may cause bed disruption, but unlikely to result in significant impacts, when undertaken with appropriate mitigation. Minor, localised disturbance to species and habitats during works. Some land loss in order to control livestock

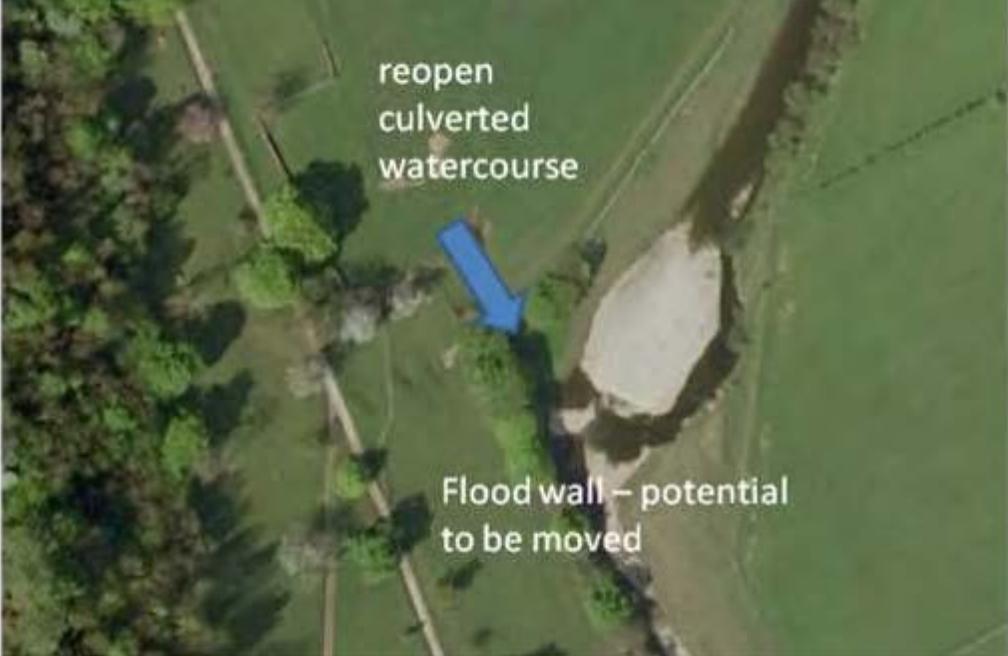
5.3.3 Southern Watgill Wood – Reach B1-O Wandering (OS Grid: 393838, 476697)

Opportunity	Actions	Positive response	Considerations and constraints
Deculverting.	Daylighting of watercourse. Potential setting back of flood defence on the left bank.	Removal of behavioural (and potential physical barrier) to lateral migration will allow exploitation of tributary by all life stages. Potential to create new in-channel and riparian habitat and will reinstate open channel habitat and will likely result in more diverse and utilisable habitat benefitting all life stages. Potential enhancement of wetland habitats (e.g. rushy pasture) upstream of culvert through increased connectivity with main river.	Minimal release of sediment during works. This will be rapidly assimilated into the transport regime and will have minimal impact on fisheries. Minor, localised disturbance to species and habitats during works.
<p>Note. This reach is within the Wharfe SSSI</p>

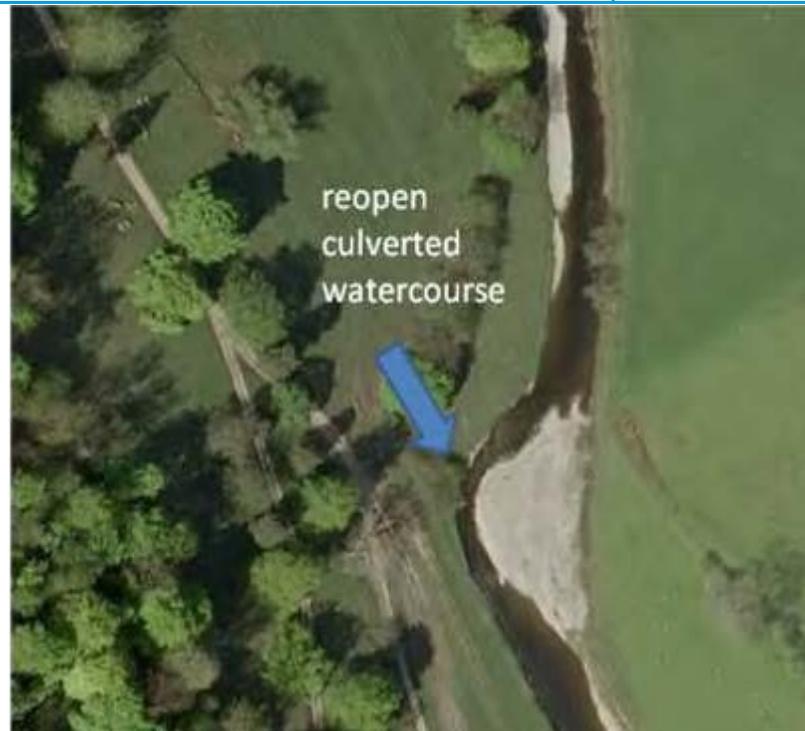
Opportunity	Actions	Positive response	Considerations and constraints
Deculverting.	Daylighting of watercourse	<p>Removal of behavioural (and potential physical barrier) to lateral migration will allow exploitation of tributary by all life stages.</p> <p>Potential to create new in-channel and riparian habitat and will reinstate open channel habitat and will likely result in more diverse and utilisable habitat benefitting all life stages.</p> <p>Potential enhancement of wetland habitats (e.g. rushy pasture) upstream of culvert through increased connectivity with main river.</p>	<p>Minimal release of sediment during works. This will be rapidly assimilated into the transport regime and will have minimal impact on fisheries.</p> <p>Minor, localised disturbance to species and habitats during works.</p>

Note. This reach is within the Wharfe SSSI

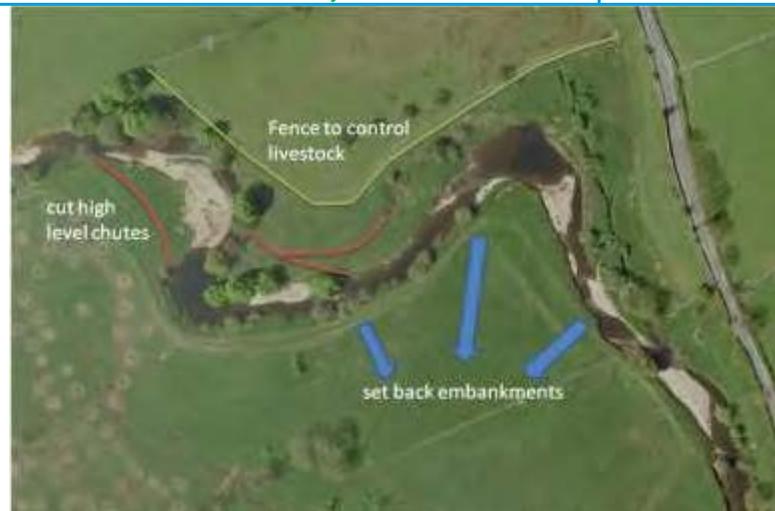
5.3.5 Eshber Wood – Reach B1-Q Wandering (OS Grid: 394399, 475933)

Opportunity	Actions	Positive response	Considerations and constraints
<p>Set back / remove flood banks. Encourage lateral activity. Develop riparian wetland.</p>	<p>Allow space for the river to migrate whilst managing flooding. Control stock access by managing grazing intensity by temporary or permanent fencing</p>	<p>Creation of temporal and habitat variety across the floodplain.</p> <p>Development of wandering and later wooded anastomosed channel types likely to provide backwater habitat opportunities, particularly valuable for juvenile life stages during normal flows.</p> <p>Reconnection of floodplain palaeo-features.</p> <p>Extension and improvement of riparian wetland habitats, such as rushy pasture, wet woodland, sedge beds and meadowsweet mire.</p> <p>Retention of suspended fines as new floodplain deposits, increasing local extent of spawning habitats.</p> <p>Setting back embankments and increasing floodplain connectivity should promote diversity and extent of riparian habitats and associated invertebrate communities and therefore an increase in abundance of prey species.</p> <p>Development of diversity of morphological features will provide increased habitat and flow diversity exploitable by all life stages</p> <p>Introduction of coarse woody debris through encouragement of lateral activity.</p>	<p>General slow transition should preclude extreme and adverse river response.</p> <p>Minor, localised disturbance to species and habitats during works.</p> <p>Potential for rank, disturbance-tolerant vegetation to develop if inundation of palaeo-features and new habitats is infrequent or compaction occurs during works.</p> <p>Operational phase unlikely to result in discernible negative impacts, although careful design of features encouraging lateral activity will be necessary to ensure stranding does not occur following high flow events in the short term. Long term benefits are likely to substantially outweigh such short term impacts however.</p> <p>Some land loss in order to control livestock</p>

Note. This reach is within the Wharfe SSSI

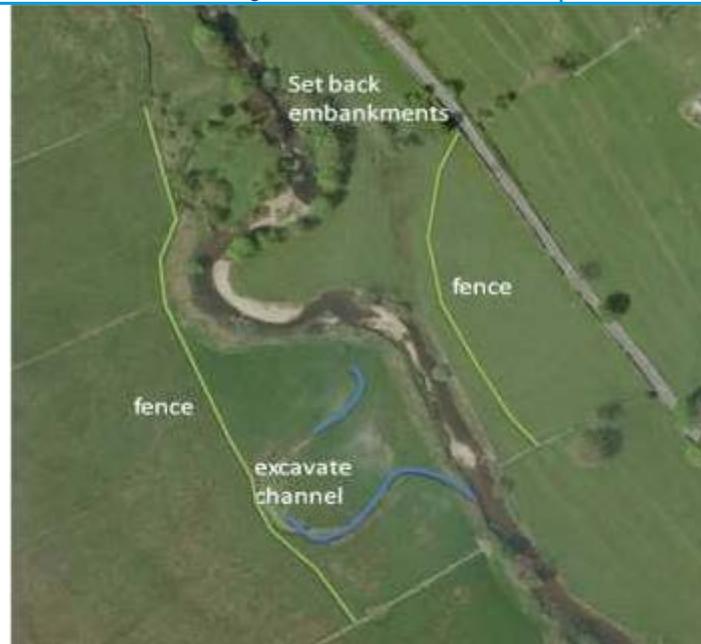
5.3.6 Firth Wood – Reach B1-Q Wandering (OS Grid: 394695, 475374)

Opportunity	Actions	Positive response	Considerations and constraints
Partial palaeo-channel reconnection	Reconnect downstream palaeo-channel exit. Allow space for the river to migrate whilst managing flooding. Set back embankments. Control stock access by managing grazing intensity by temporary or permanent fencing	<p>Rejuvenation of old course wetland area and creation of additional flood storage. This is likely to provide small backwater habitat opportunities, particularly refuge habitat for juvenile life stages during high flows.</p> <p>Increasing connections with existing palaeo-features should promote diversity and extent of wetland habitats and associated invertebrate communities and therefore an increase in abundance of prey species.</p> <p>Locus for fine sediment deposition</p> <p>Enhancement of wetland habitats within floodplain, such as rushy pasture through increased inundation.</p> <p>Promotion of lateral channel movement likely to give rise to increased diversity of morphological features exploitable by all life stages.</p>	<p>General slow transition should preclude extreme and adverse river response.</p> <p>Minor, localised disturbance to species and habitats during works. Fine sediment mobilisation during construction phase unlikely to result in significant impacts, when undertaken with appropriate mitigation.</p> <p>Some land loss in order to control livestock</p>

Note. This reach is within the Wharfe SSSI

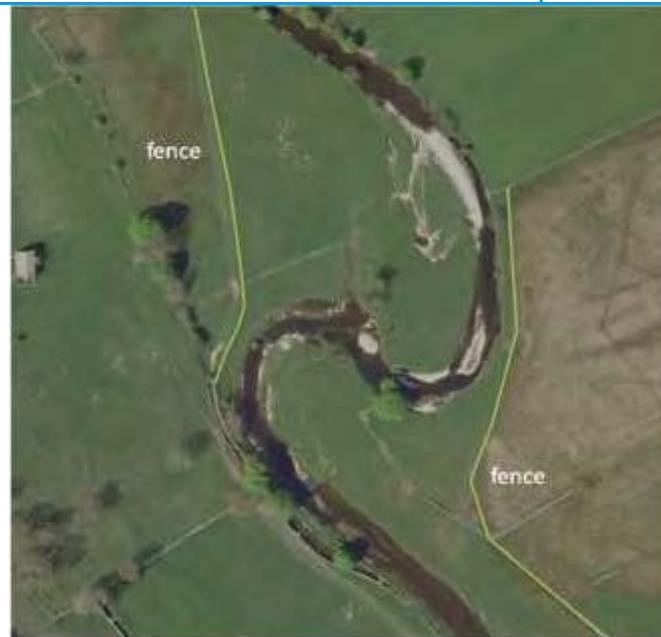
5.3.7 Hall Ings – Reach B1-T Wandering (OS Grid: 395335, 474059)

Opportunity	Actions	Positive response	Considerations and constraints
Set back / remove flood banks. Encourage lateral activity.	Allow space for the river to migrate whilst managing flooding. Control stock access by managing grazing intensity by temporary or permanent fencing	<p>Creation of temporal variety across the floodplain.</p> <p>Development of wandering and later wooded anastomosed channel types.</p> <p>Setting back embankments and increasing floodplain connectivity should promote diversity and extent of riparian habitats and associated invertebrate communities and therefore an increase in abundance of prey species.</p> <p>Development of diversity of morphological features will provide increased habitat and flow diversity exploitable by all life stages.</p> <p>Creation of better connected riparian zones and enhancement of the wetland habitats within it, including rushy pasture and sedge beds.</p> <p>Retention of suspended fines as new floodplain deposits.</p>	<p>General slow transition should preclude extreme and adverse river response.</p> <p>Minor, localised disturbance to species and habitats during works. Operational phase unlikely to result in discernible negative impacts.</p> <p>Some land loss in order to control livestock</p>

Note. This reach is within the Wharfe SSSI

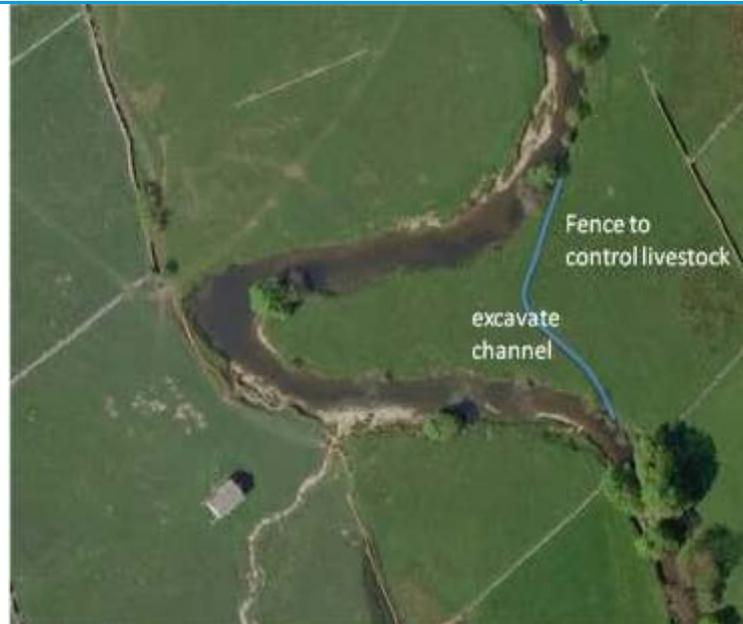
5.3.8 Falcon Beard Sike – Reach B1-T Wandering (OS Grid: 395585, 473625)

Opportunity	Actions	Positive response	Considerations and constraints
Meander cutoff	Create 'chute' channel. Control stock access by managing grazing intensity by temporary or permanent fencing	<p>High flow 'chute' will provide new periodically wet gravel habitat, and increase habitat diversity within the floodplain. Potential for creation of more 'natural' habitats on 'island' created behind chute channel.</p> <p>Erosion pressure on original meander bend will be much reduced.</p> <p>Retention of valuable deeper pool refuge and feeding station habitat, likely to be exploited by larger adult fish, on meander bend.</p> <p>Reduction in erosion pressure on meander bend Development of diversity of morphological features will provide increased habitat and flow diversity exploitable by all life stages.</p>	<p>Likely to cause longer term channel adjustment up and downstream but this mimics natural cutoff process. Minor, localised disturbance to species and habitats during works.</p> <p>Where geology allows, young backswamp/oxbow features seemingly already infrequent along project stretch. Prevention of maturation of this feature into such will not improve this situation. However, retention of diverse habitat promoted by this proposal will likely outweigh any limitation associated with natural development of backswamp/oxbow feature Some land loss in order to control livestock</p>

Note. This reach is within the Wharfe SSSI

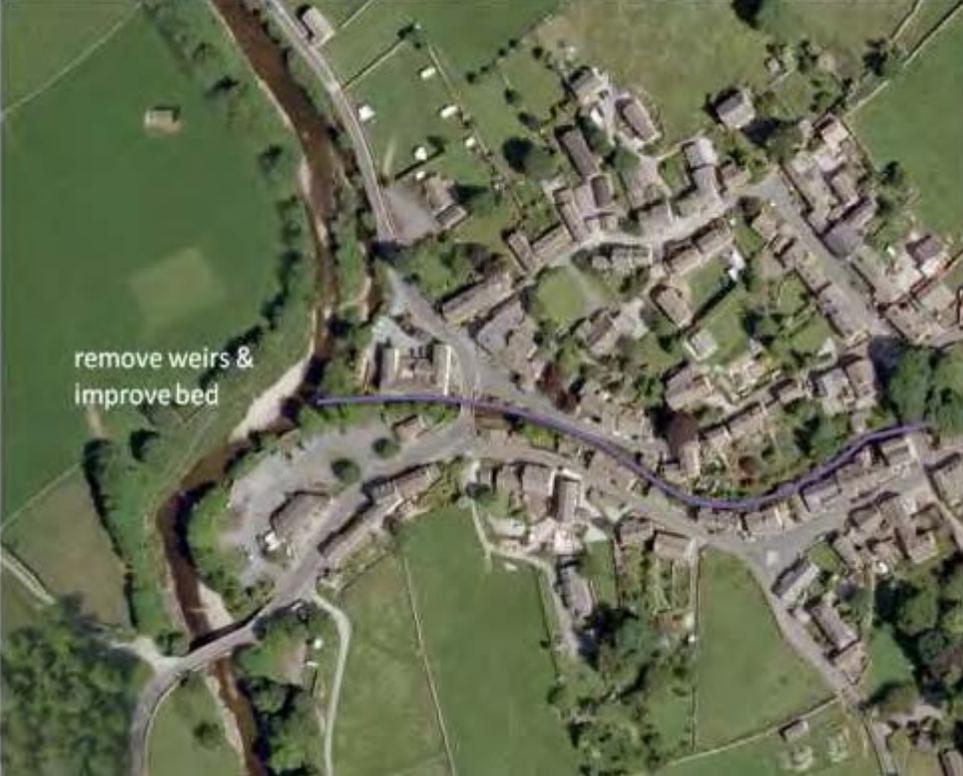
5.3.9 Kettlewell – Tributary of Reach B1-W Wandering (OS Grid: 396824, 472333)

Opportunity	Actions	Positive response	Considerations and constraints
Improvements to tributary watercourse.	Removal of weir sequence.	Removal of physical barrier to lateral migration will allow exploitation of tributary by all life stages.	<p>Minimal release of stored sediment into the main channel. This will be rapidly assimilated into the transport regime. Minor, localised disturbance to species and habitats during works, particularly fish populations.</p> <p>Fine sediment mobilisation during construction phase unlikely to result in significant impacts, when undertaken with appropriate mitigation.</p> <p>Operational phase unlikely to result in discernible negative impacts.</p>
<div style="display: flex; justify-content: space-between;"> <div data-bbox="219 676 450 767" style="width: 20%;"> <p>Note. This reach is within the Wharfe SSSI</p> </div> <div data-bbox="584 639 1547 1415" style="width: 50%; text-align: center;">

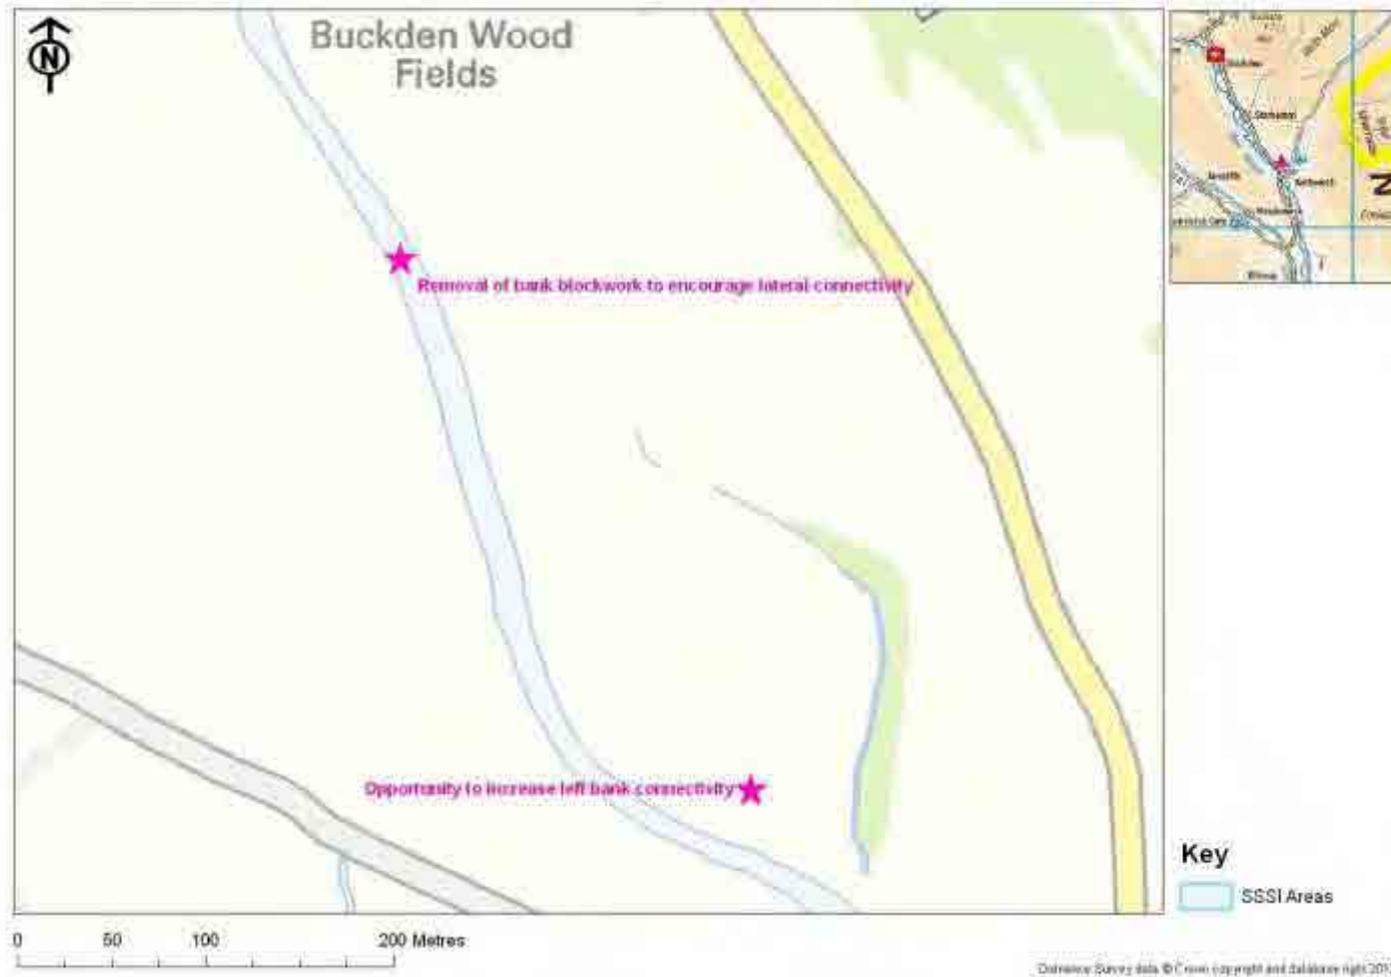
5.4.3 Reach B2 – L (outside of the SSSI)

Existing Problem	Proposed Action	Potential Benefits	Potential negative impacts or constraints	Notes
Traditional walling and bank protection along the channel edges prevents lateral erosion and creates a uniform channel.	Local removal of channel walls and toe protection to reinstate lateral erosion	The majority of lateral erosion as a result of removing bank protection will occur within the existing buffer strip resulting in minimal impacts on farmland. Riparian woodland planting could be undertaken to provide a further buffer strip for any extreme lateral migration. New lateral erosion will reduce the current uniformity of this straight section and will help to create more diverse in channel morphology and habitat. The re-instatement of erosive processes will introduce coarse woody debris into the channel over time, again increasing in-channel habitat diversity.	Some loss of farmland due to increased erosion. Traditional walling may be an important historic landscape feature; the impact of its removal will need to be assessed. The footpath on the right bank could be at risk of erosion as the channel naturally adjusts.	Long term monitoring of erosion rates should be carried out. Buffer strips could be used to control extreme erosion. An assessment of the historic landscape impact of traditional wall removal will be needed. Potential change in current farming practice needs to be agreed with landowners, with appropriate support where necessary

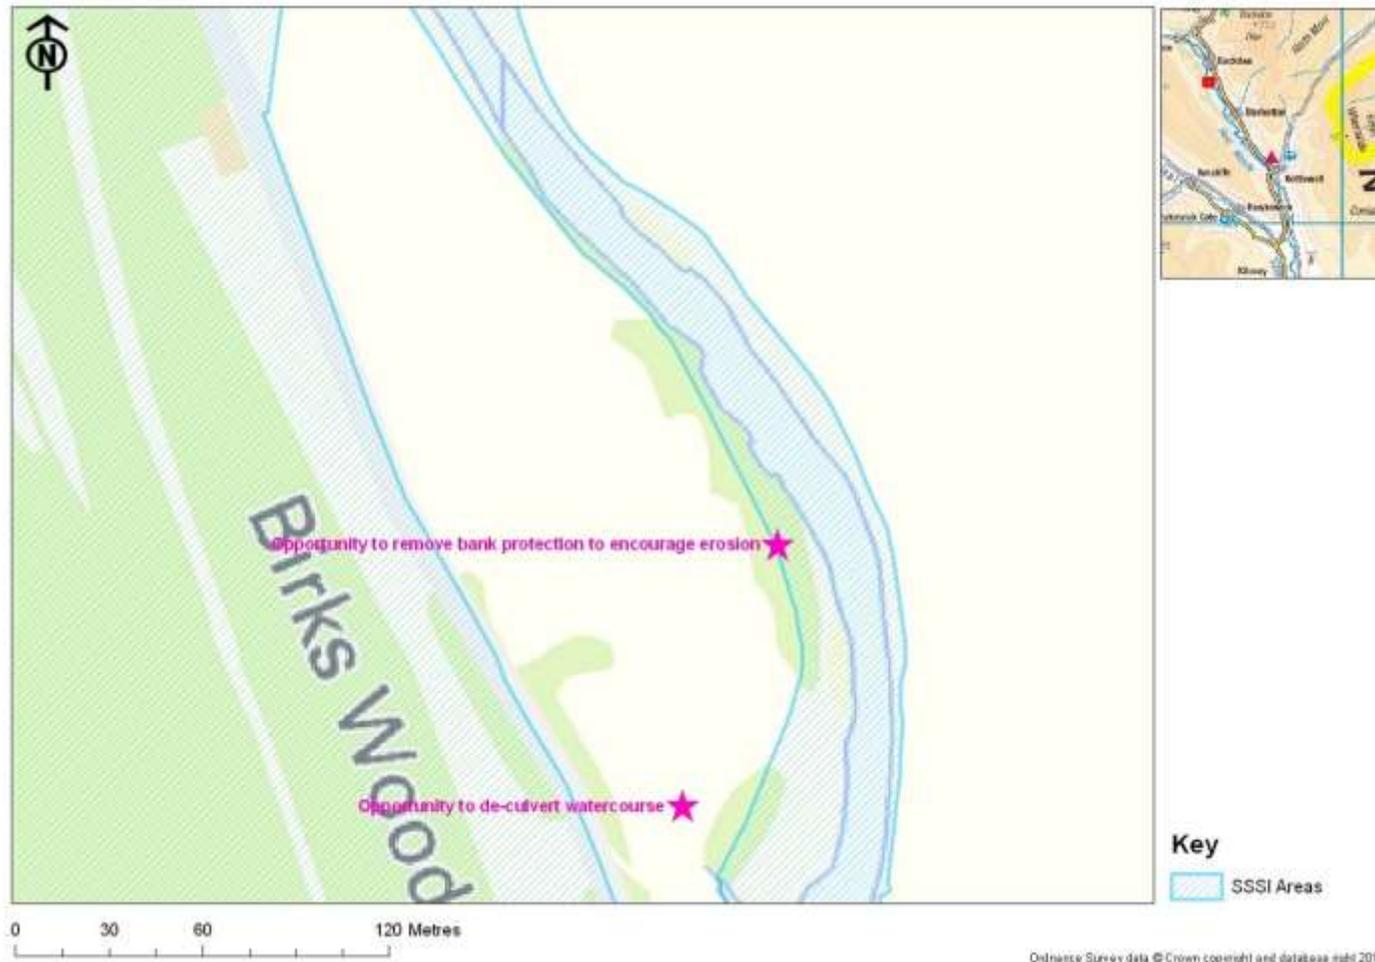
5.4.7 Reach B2 – P (inside the SSSI)

Existing Problem	Proposed Action	Potential Benefits	Potential negative impacts or constraints	Notes
Traditional walling and bank protection along the channel edges prevents lateral erosion and creates a uniform channel. The right bank is also high and limits connectivity.	Limited bank protection and flood banks exist which has resulted in lateral erosion being frequently observed in this reach. In the few places where protection does exist it should be removed to further encourage lateral erosion. The right bank could be slightly lowered to improve connectivity.	New lateral erosion will make the channel less uniform and will help to create more diverse in-channel morphology and habitat. Improved connectivity would help create additional and enhance existing wetland areas on the right bank floodplain	Some reduction in farmland Traditional walling may be an important historic landscape feature; the impact of its removal will need to be assessed. Ornamental planting may be adversely affected by increased inundation on right bank.	Further riparian woodland planting could be undertaken to provide a further buffer strip for any extreme lateral migration. An assessment of the historic landscape impact of traditional wall removal will be needed. Potential change in current farming practice needs to be agreed with landowners, with appropriate support where necessary

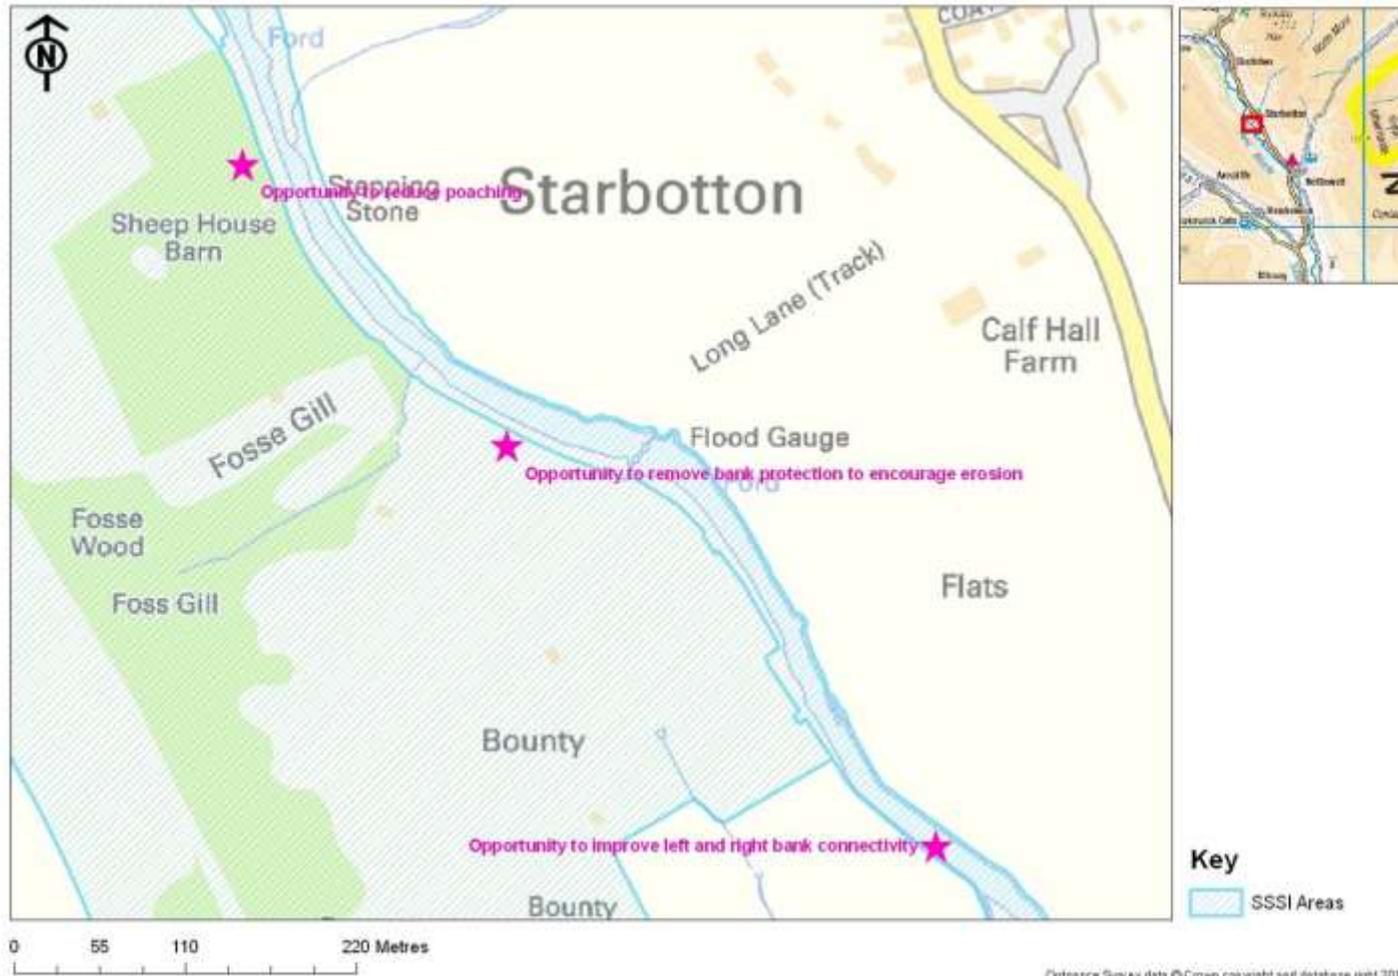
5.4.10 Reach B4 – S (inside the SSSI)

Existing Problem	Proposed Action	Potential Benefits	Potential negative impacts or constraints	Notes
High banks (left and right) causing poor floodplain connection.	Removal and / or modification of flood banks (in the few places where they exist) and to improve floodplain connectivity.	Removal of banks would help to restore the natural flood regime and help to increase in channel morphology and habitat diversity. The existing rushy pasture area could be developed further into a diverse wetland habitat.	Some loss of farmland	Potential change in current farming practice needs to be agreed with landowners, with appropriate support where necessary
Traditional walling and bank protection along the channel edges prevents lateral erosion and creates a uniform channel.	Local removal of channel walls and toe protection to reinstate lateral erosion	Lateral erosive processes will be re-instated by the removal of bank walls. Overtime this will reduce the rate of incision and begin to re-instate a natural flow regime in the channel and increase habitat diversity. Removal of the existing protection will also reduce the current channel uniformity of the existing bank profile. Improvements will also be achieved for biodiversity and the aesthetic appearance of the channel. The re-instatement of erosive processes will introduce coarse woody debris into the channel over time, again increasing in-channel habitat diversity.	The footpath could be at greater risk of erosion. Traditional walling may be an important historic landscape feature; the impact of its removal will need to be assessed.	Monitoring would need to be undertaken to assess the rate of channel adjustment. An assessment of the historic landscape impact of traditional wall removal will be needed.

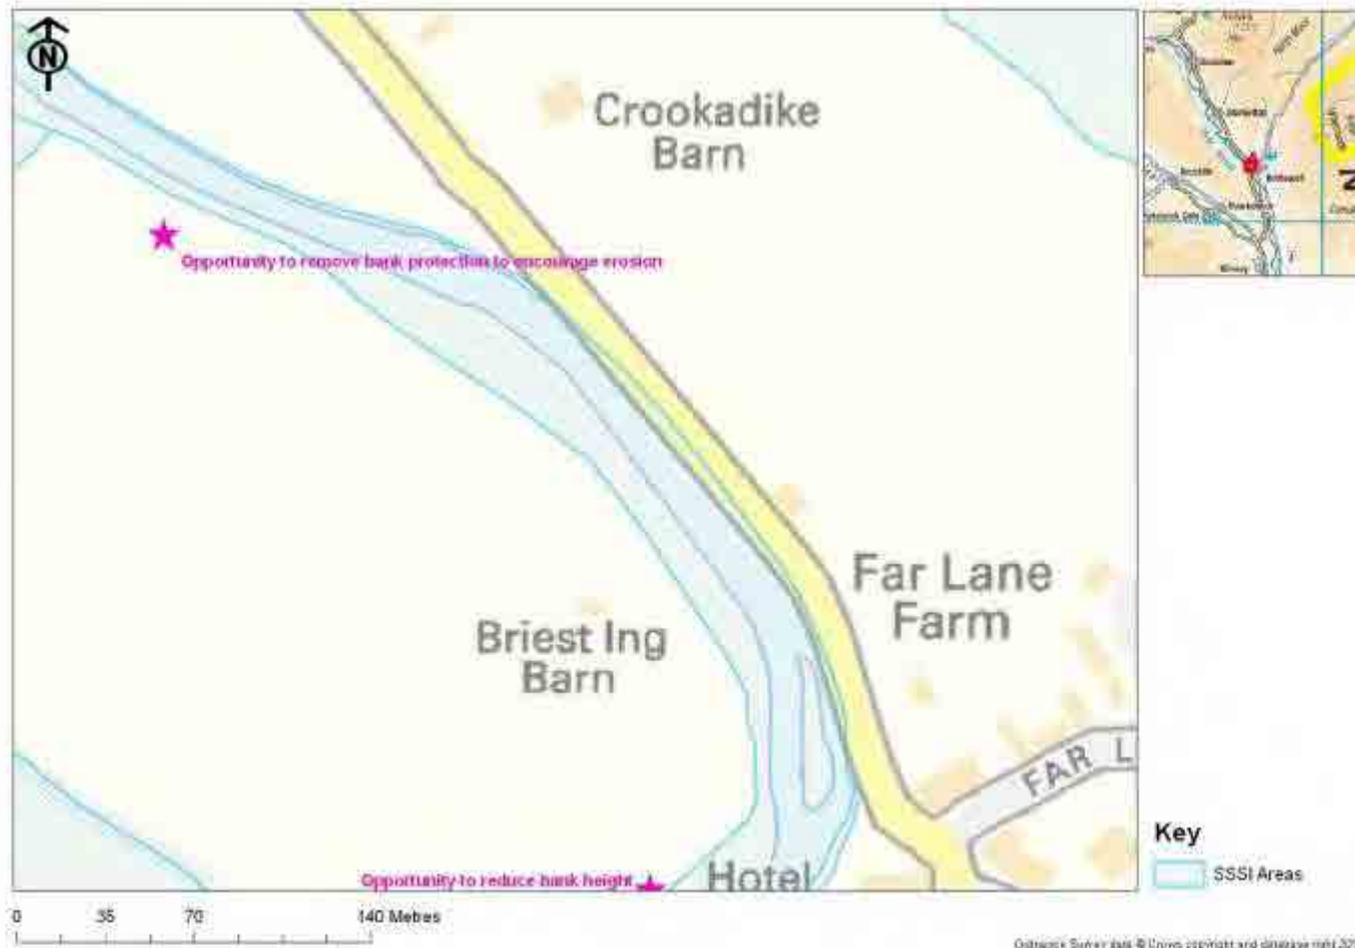
5.4.13 Reach B4 – V (inside the SSSI)

Existing Problem	Proposed Action	Potential Benefits	Potential negative impacts or constraints	Notes
Traditional walling and bank protection along the channel edges prevents lateral erosion and creates a uniform channel.	Removal of flood banks, especially on the left hand bank in the upper section of this reach to improve floodplain connectivity	Much better floodplain connectivity	Increased levels of extreme erosion could occur. Traditional walling may be an important historic landscape feature; the impact of its removal will need to be assessed.	In cases of extreme erosion soft management solutions could be introduced. An assessment of the historic landscape impact of traditional wall removal will be needed. If removal of walls threatens the road, use soft engineering techniques short term to stop it, and pre-emptively plant blocks of suitable trees to reduce risk of erosion and associated future bank protection.

High right bank limiting connectivity upstream of Kettlewell.	Improvement of right bank connectivity slightly upstream of Kettlewell by reducing bank height	Much better floodplain connectivity and possible reduction in floodlevels	Confined channel through Kettlewell so connectivity is limited	Re connecting the right floodplain upstream of Kettlewell will aid in reduction off flood levels.

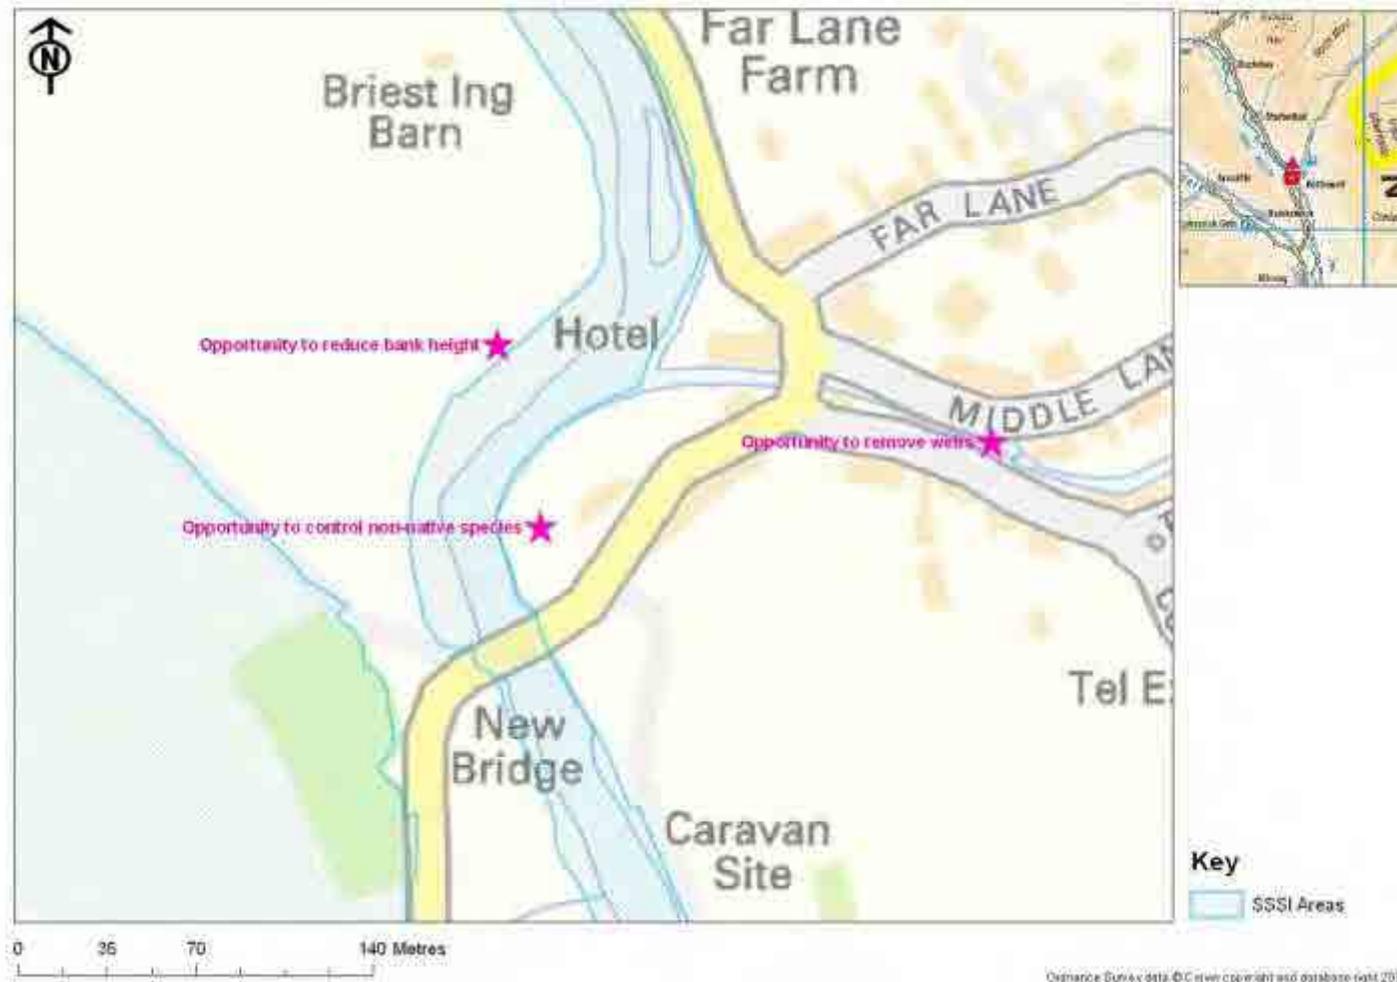
5.4.14 Reach B1 – W (inside the SSSI)

Existing Problem	Proposed Action	Potential Benefits	Potential negative impacts or constraints	Notes
Himalayan Balsam present on left bank upstream of Kettlewell.	Non-native species control	Eradication of Himalayan Balsam stand	N/A	N/A
Limited restoration options are available through Kettlewell due to the confined nature of the channel.	Improvements could be made on Kettlewell Beck such as weir removal any other improvements such as riparian management/shading other in channel diversity measures.	Improve in channel morphology. Improved fish passage along Kettlewell Beck.	N/A	N/A

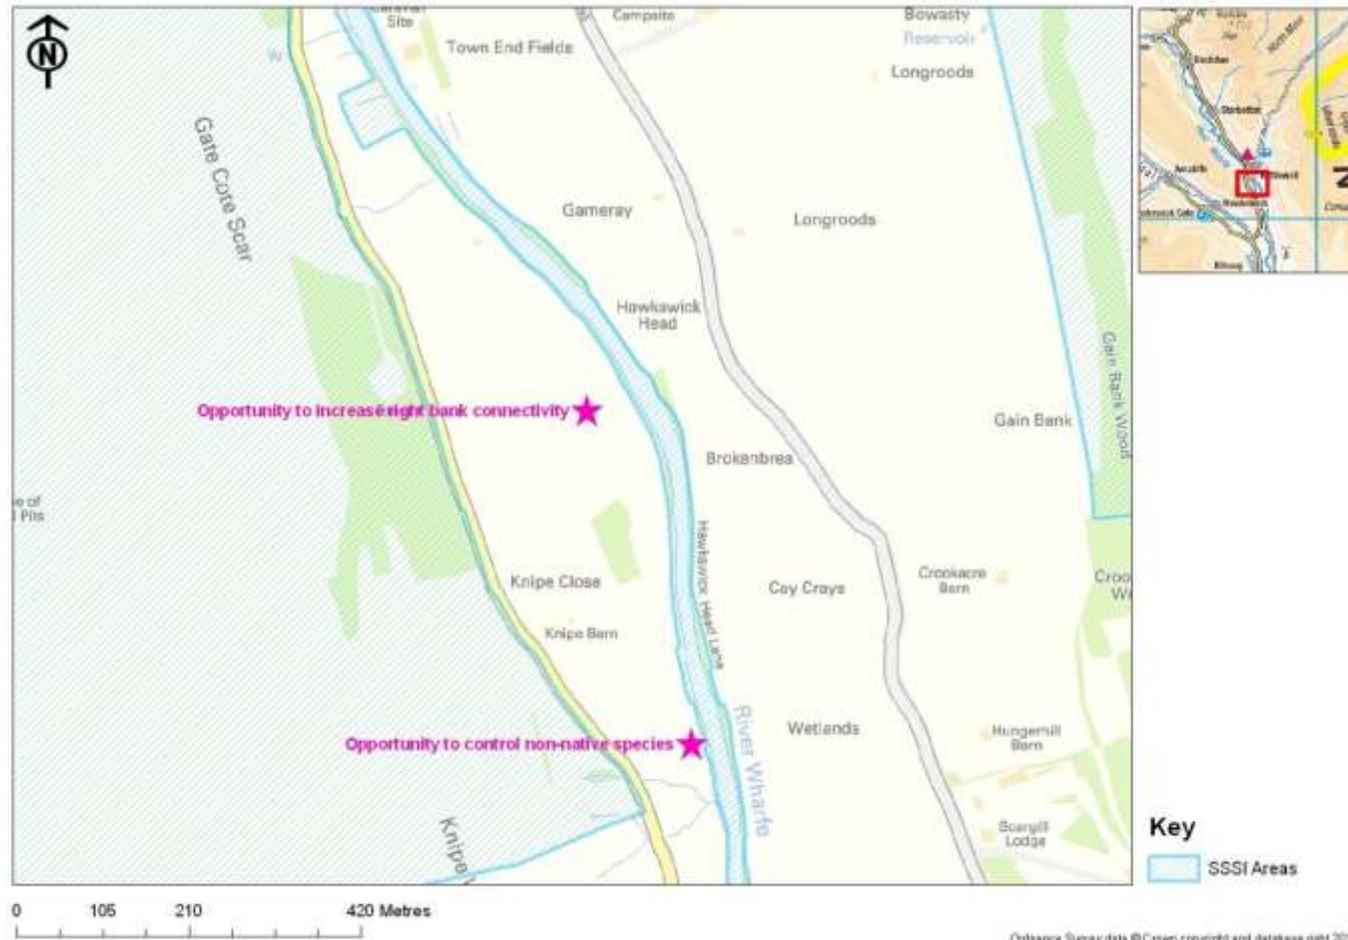
5.4.15 Reach C1 – X (inside the SSSI)

Existing Problem	Proposed Action	Potential Benefits	Potential negative impacts or constraints	Notes
Traditional walling and bank protection along the channel edges prevents lateral erosion and creates a uniform channel.	Removal of bank revetment	The removal of this protection will allow further erosion to take hold and will in the long term help to improve channel morphology and provide more diverse bed conditions and in channel habitats. The re-instatement of erosive processes will introduce coarse woody debris into the channel over time, again increasing in-channel habitat diversity.	Traditional walling may be an important historic landscape feature; the impact of its removal will need to be assessed.	Improved education and awareness of why restoration work is being undertaken. An assessment of the historic landscape impact of traditional wall removal will be needed.
Erosion due to poaching	Improvements to the riparian corridor.	Introduction of a buffer zone will stop grazing at the channel edge.	Some amenity loss for walkers and anglers as the river will be less visible from the footpath.	Access point could be created into the buffer zone. Potential change in current farming practice needs to be agreed with landowners, with appropriate support where necessary
