# IMPROVING WATER QUALITY ON THE RIVER WHARFE FROM OUGHTERSHAW TO THE OUSE: A CITIZEN SCIENCE PROJECT

Identifying sources of faecal bacteria in the River Wharfe in Upper Wharfedale 2021

Improving water quality on the River Wharfe from Oughtershaw to the Ouse: a citizen science project

# Identifying sources of faecal bacteria in the River Wharfe in Upper Wharfedale 2021

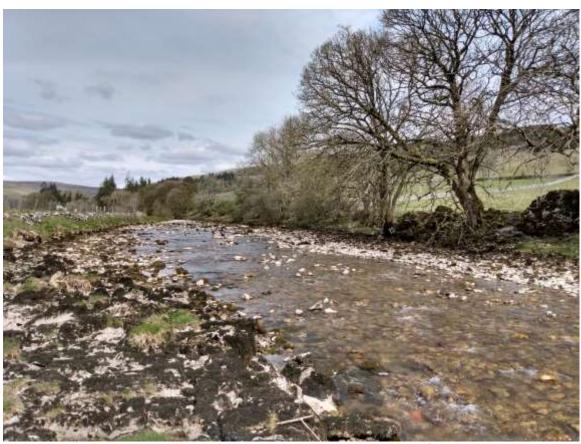
Low water in the R. Wharfe below Scargill House on the 26th April 2021

Three surveys were conducted, in April, June and July of 2021 respectively. However, in marked contrast to 2020, riverflow on each of the 2021 survey dates was very low (Fig. 2). Consequently, whilst the data afforded valuable insights into faecal bacteria patterns in dry weather, low flow conditions we were unable to answer some of our specific questions, as set out below, which depended on sampling during average to high flow conditions.
